Experiencias de intervención e investigación: buenas prácticas, alianzas y amenazas IV

Universidad
Externado
de Colombia

Filipe Castro
Bogotá, April 2021

The Cais do Sodré Shipwreck, Lisbon, Portugal

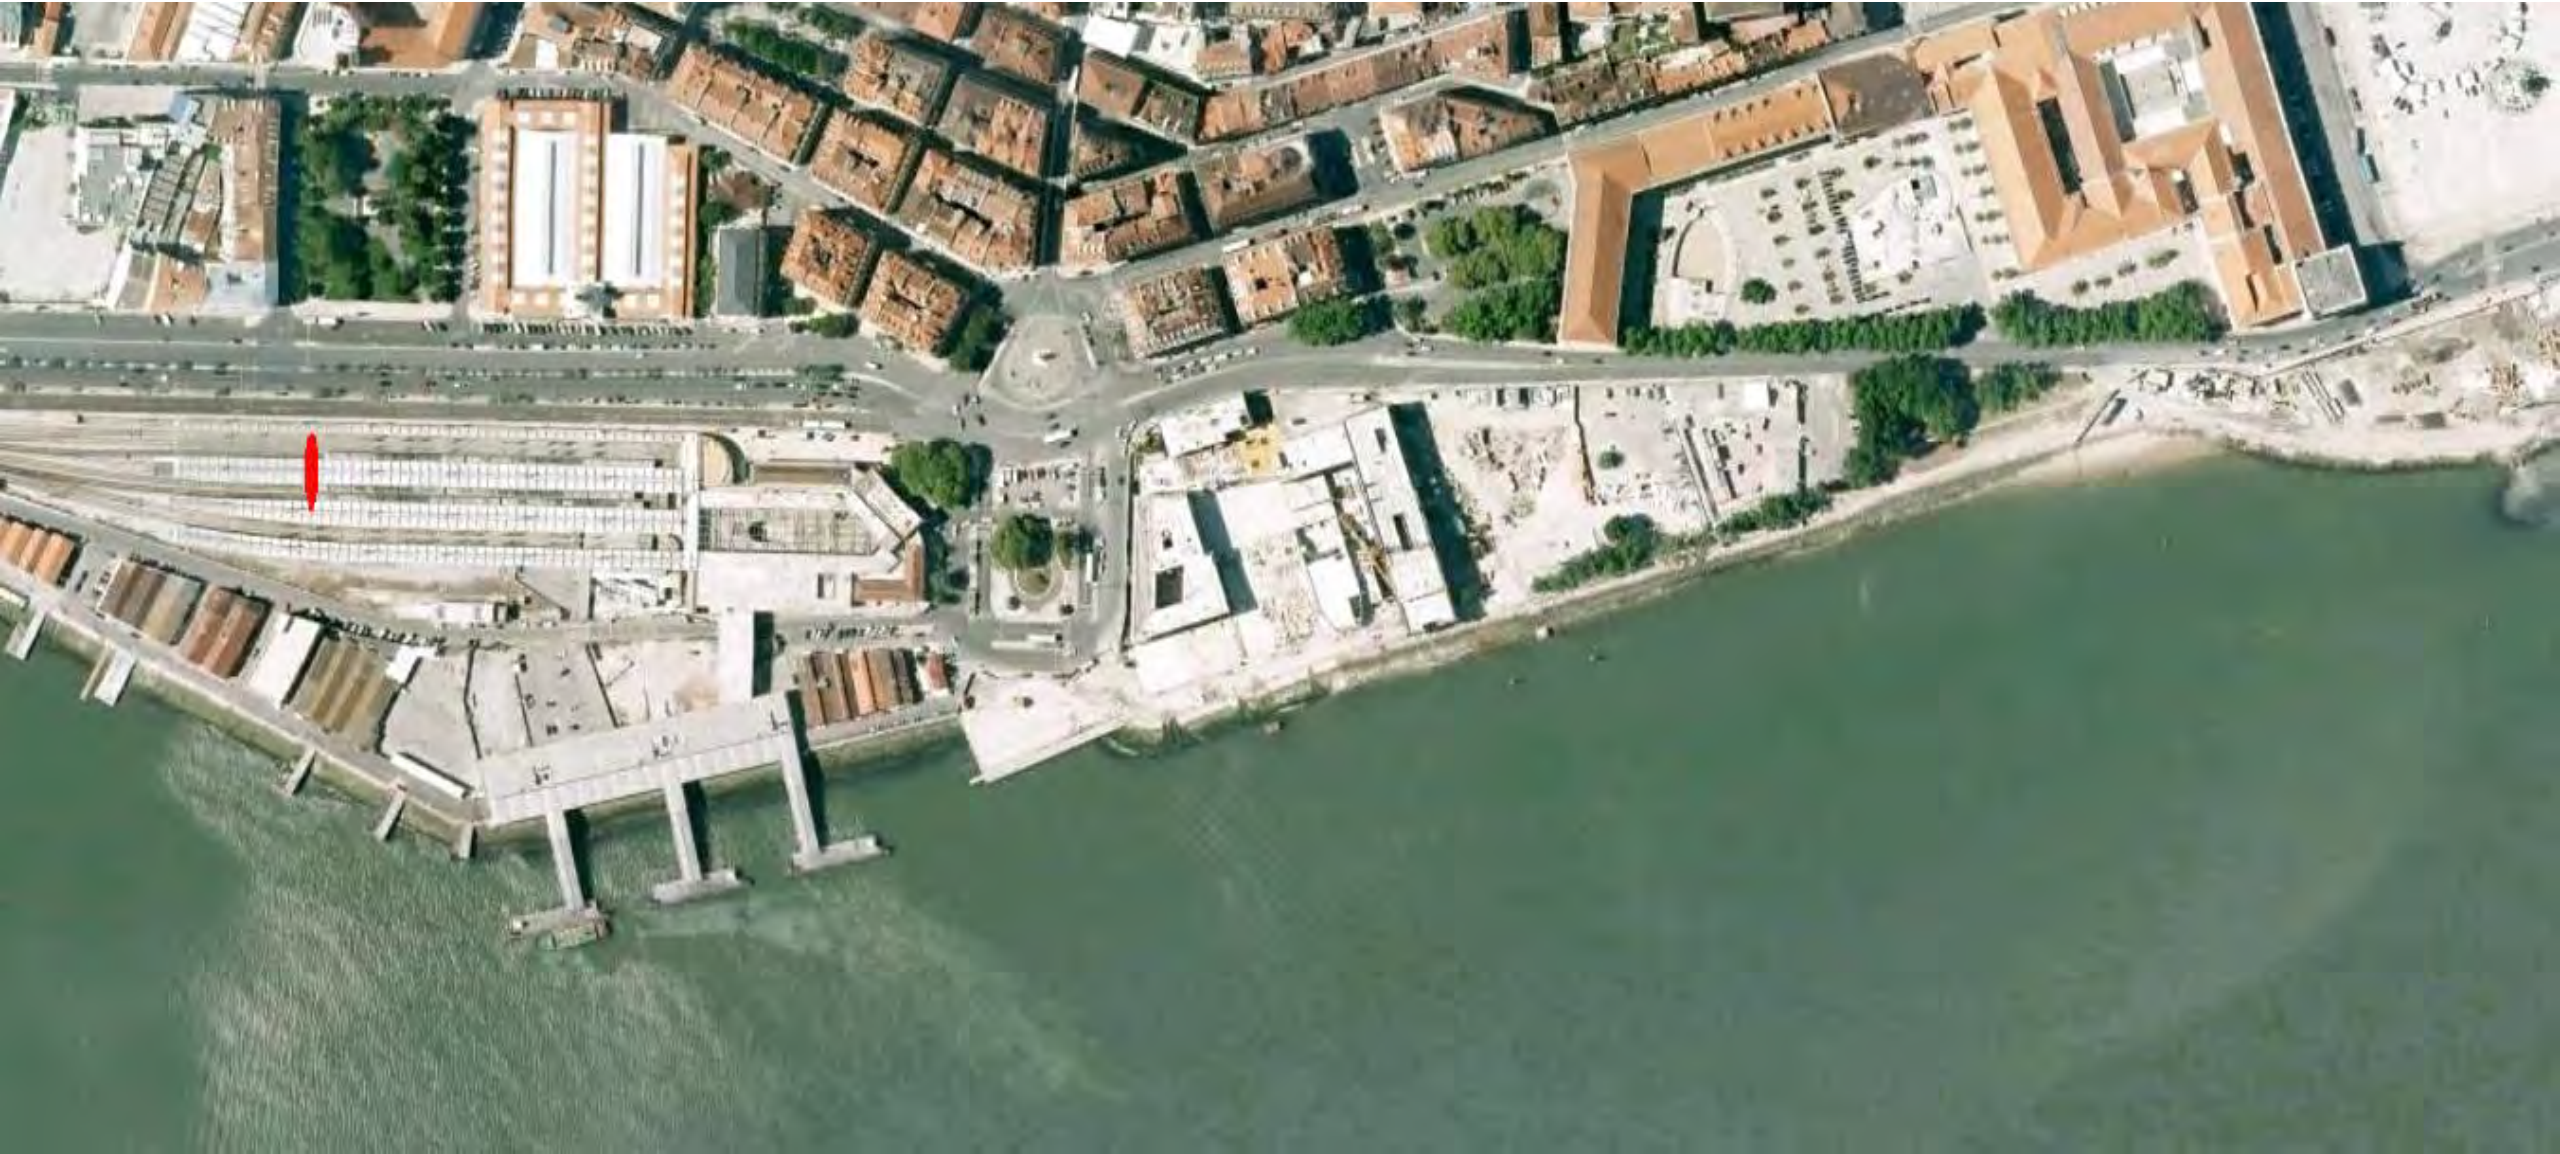
The ship was lying perpendicularly to the axis of the subway gallery being excavated, 6.5 m below the water level, and its bow and stern were cut by the subway walls.

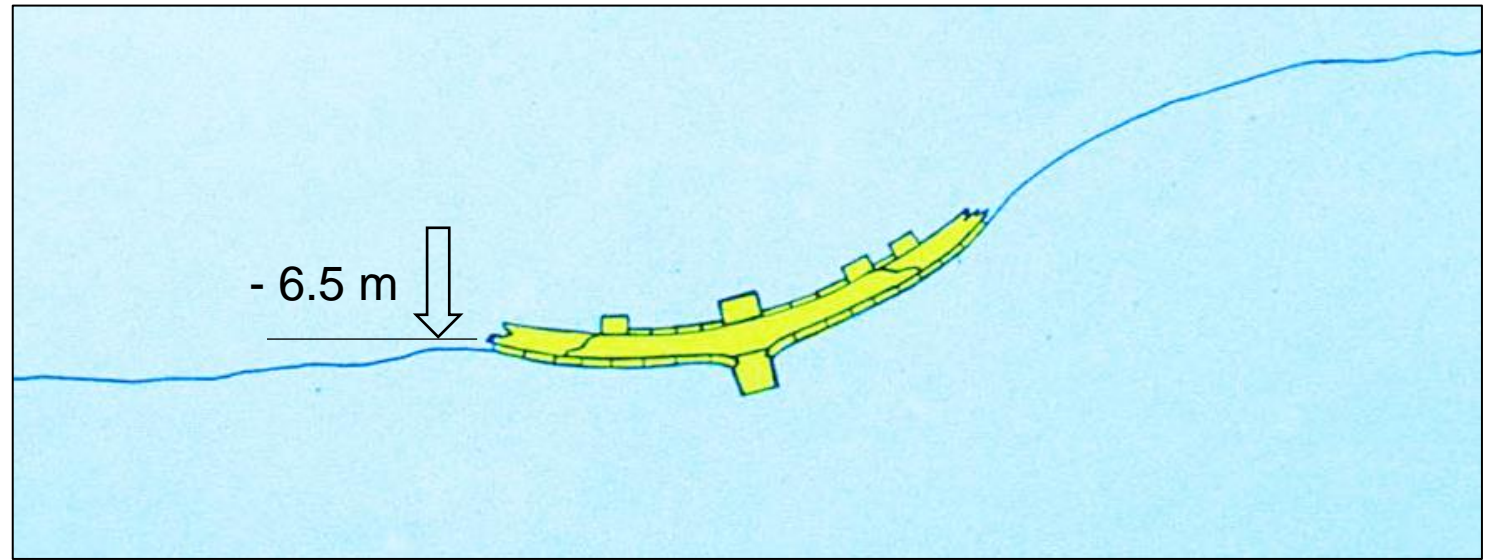
Radiocarbon analysis placed this structure around the 16th century:

Hull plank: 400 ± 40 BP

Floor timber: 430 ± 45 BP

Which calibrated gave the date 1449 in the Stuiver & Pearson curve:

1σ - 1438-1478 AD;

2σ - 1424-1516 AD / 1590-1622 AD

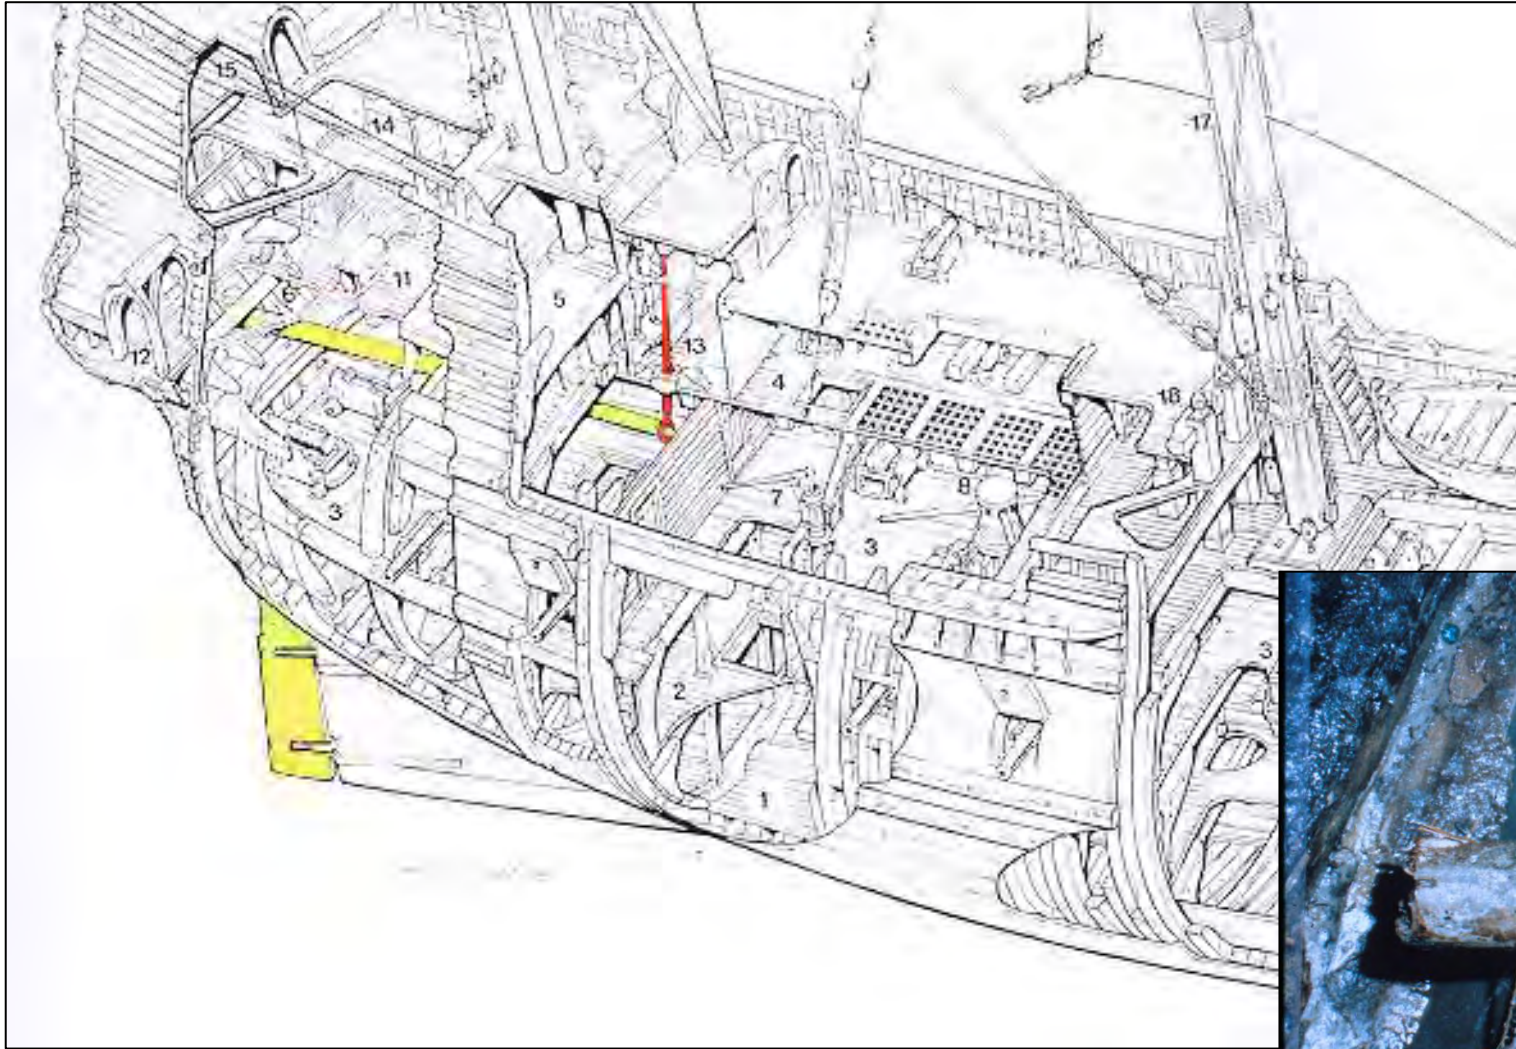
A whipstaff was found in the proximity of this shipwreck.

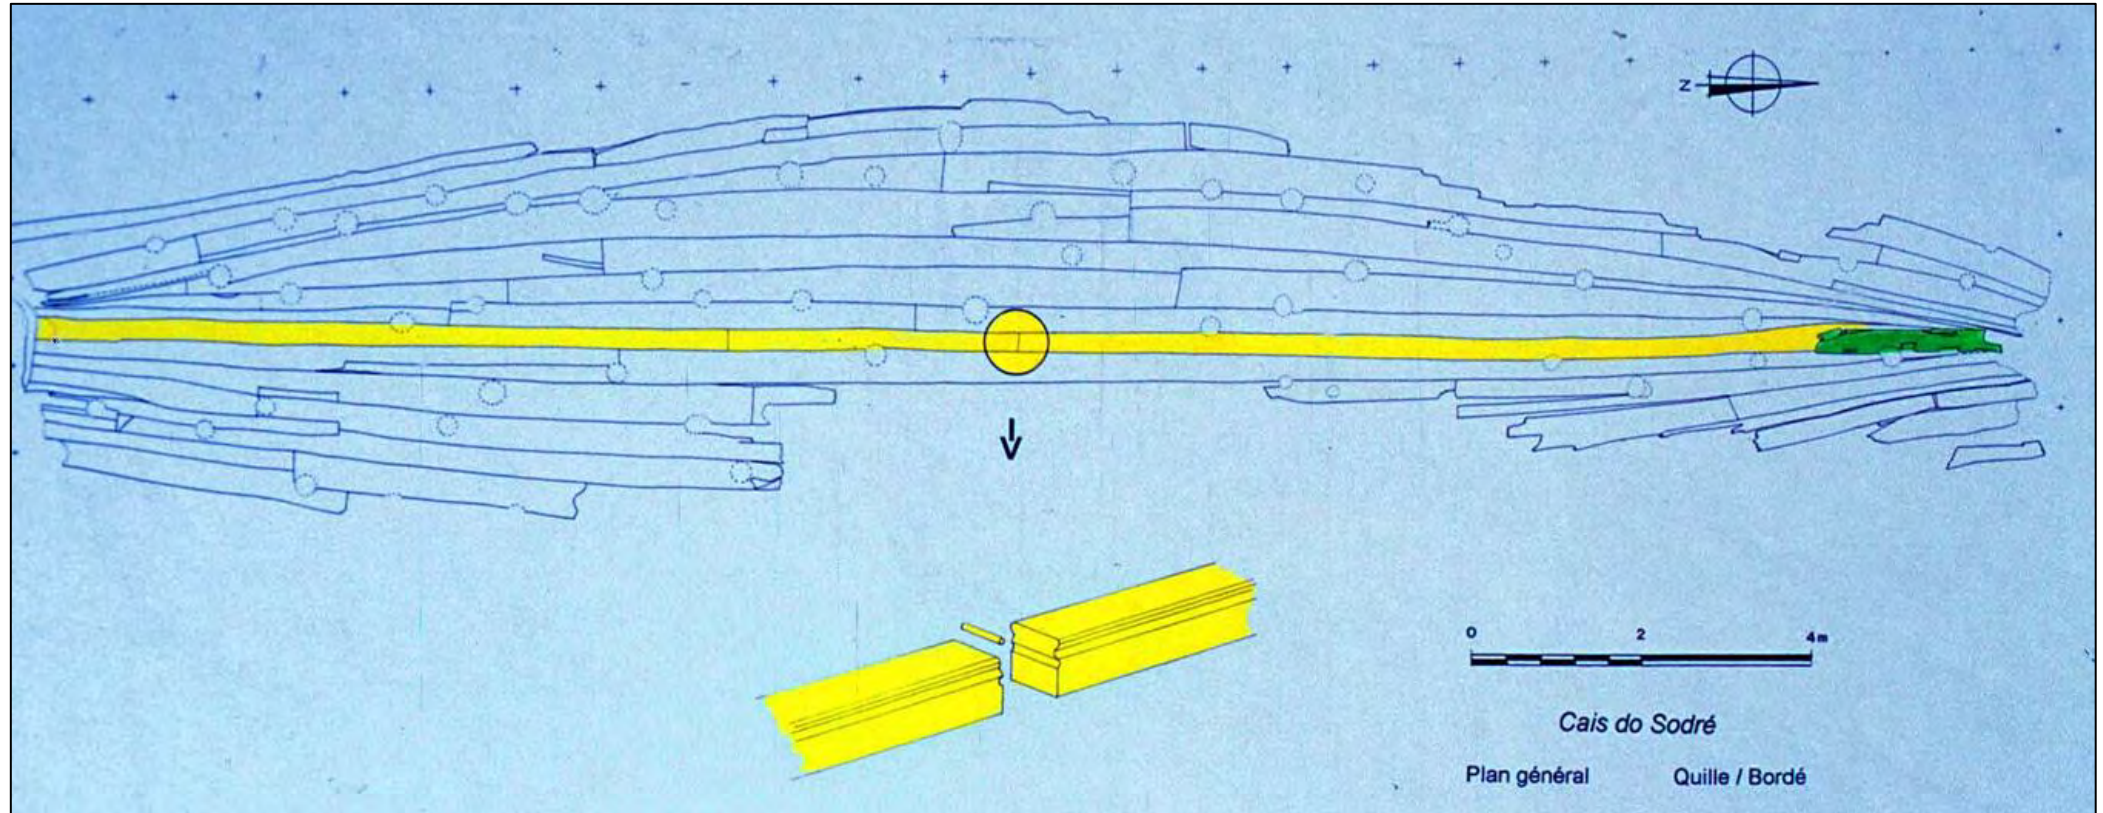
1. The keel sections were not connected with scarves;

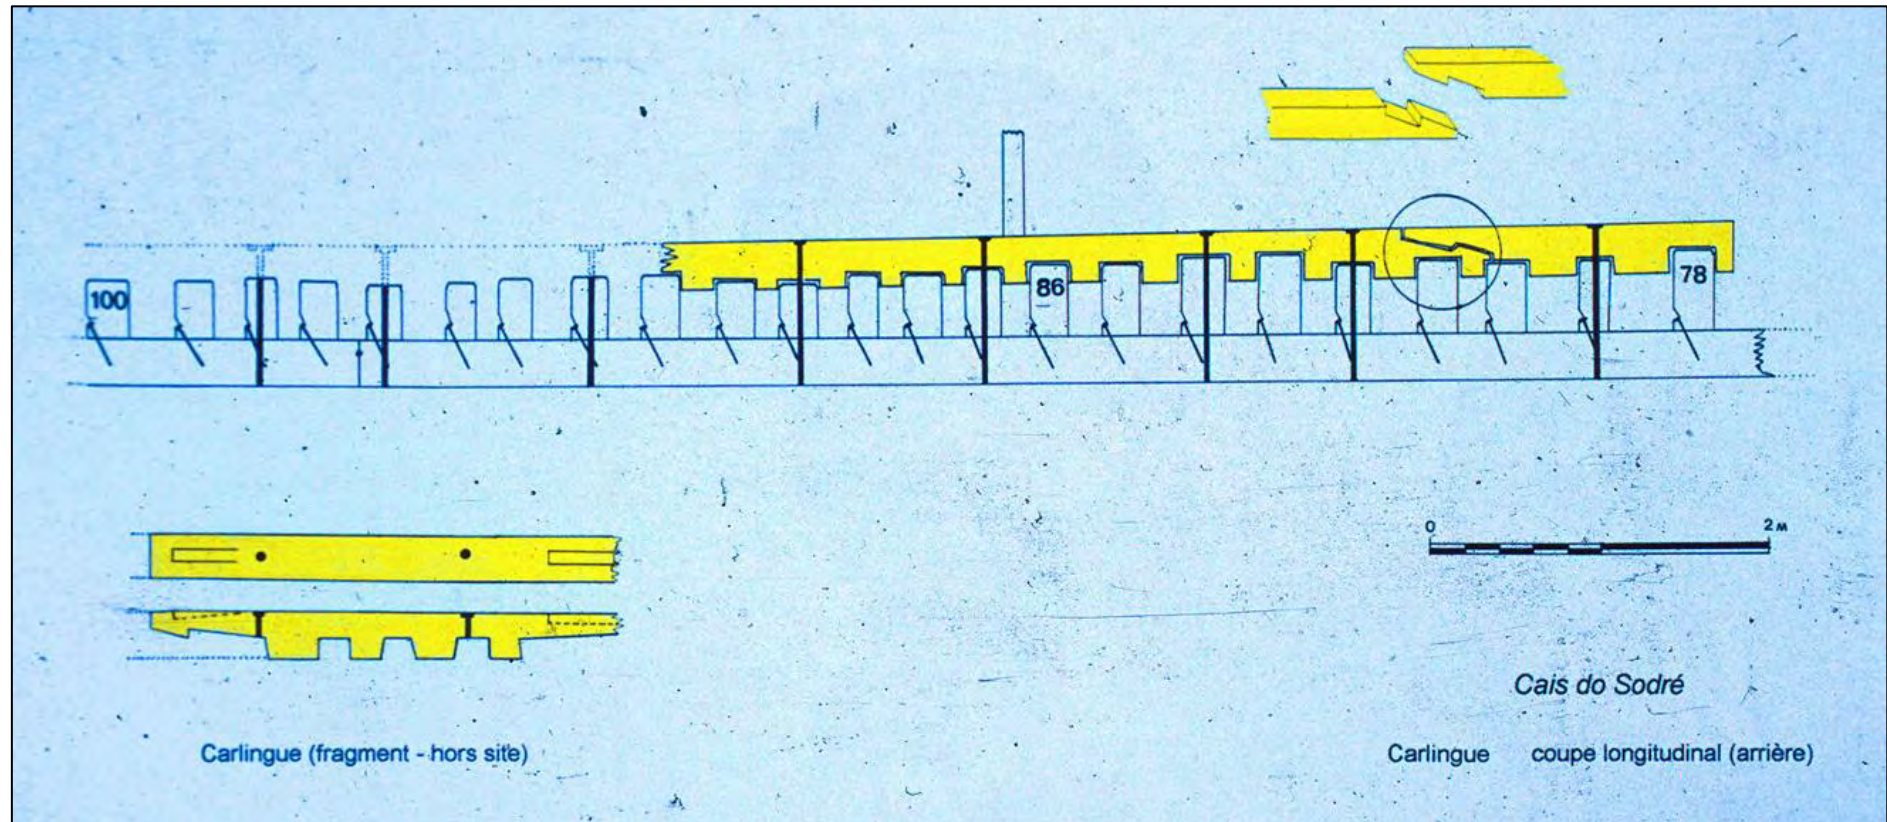
2. The keelson was notched and scarved with hook scarves;

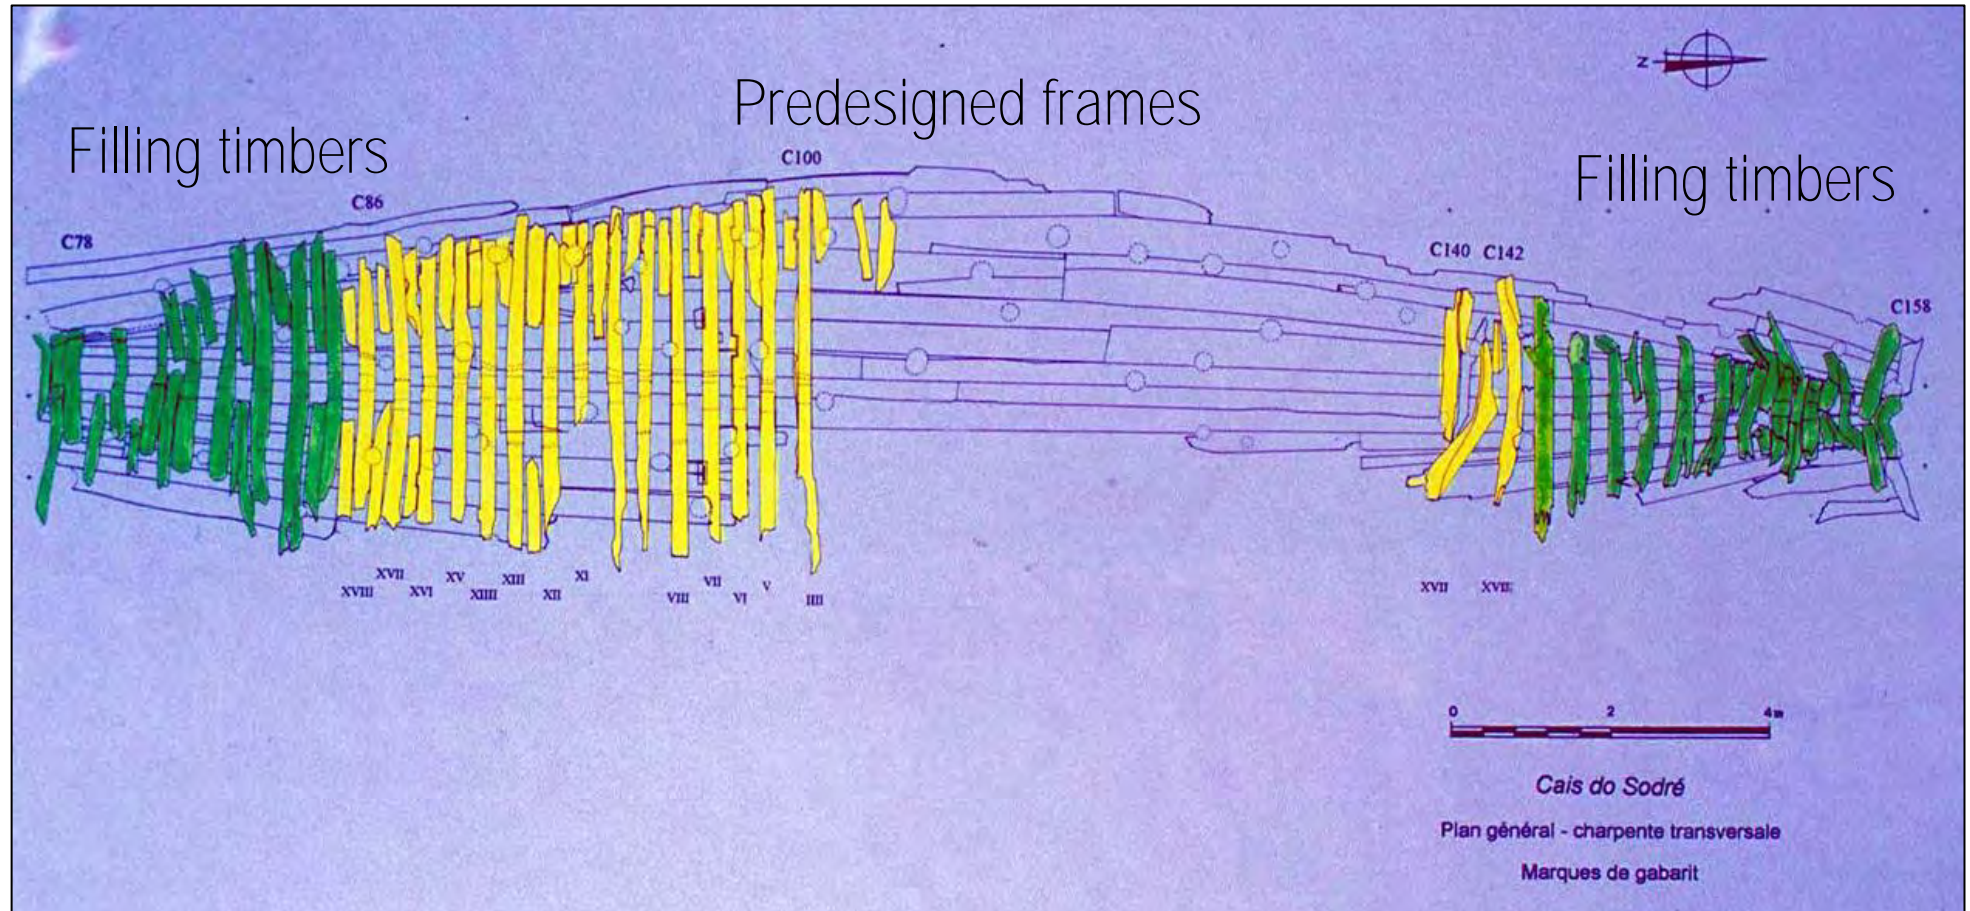
3. Frames divided into two groups;

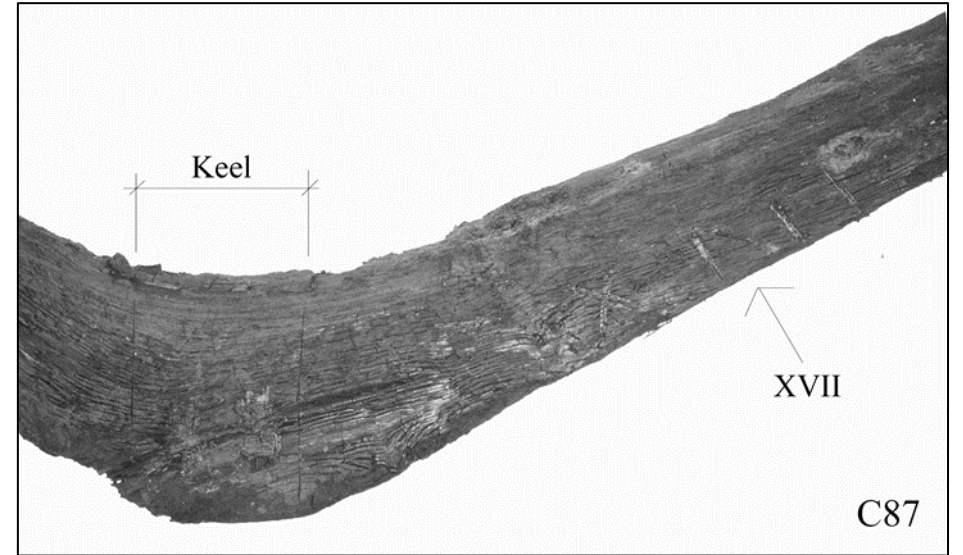
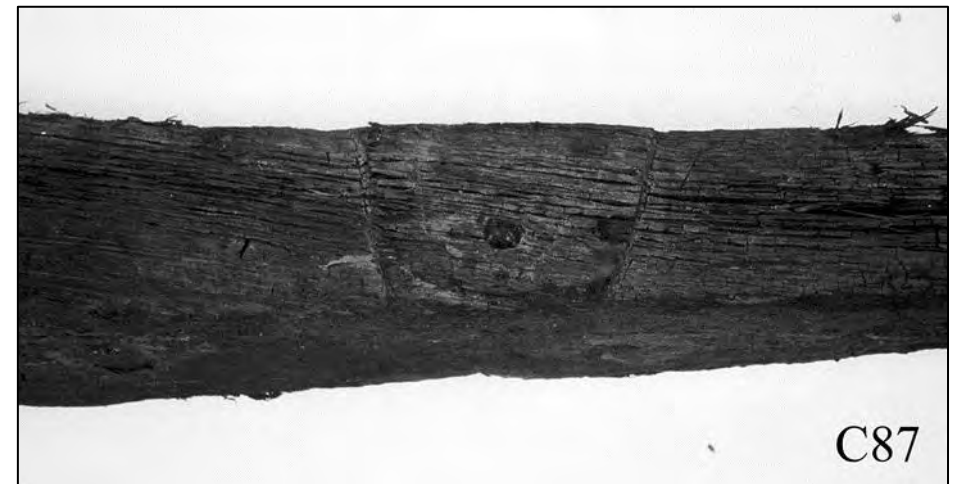
a. Predesigned frames;

1. Numbered with Roman numerals, from I to XVII;
2. Fastened to the keel with a vertical spike;
3. Connected to the futtocks with dovetail scarves;
4. Bearing keel marks;
5. Possibly turn of the bilge marks.

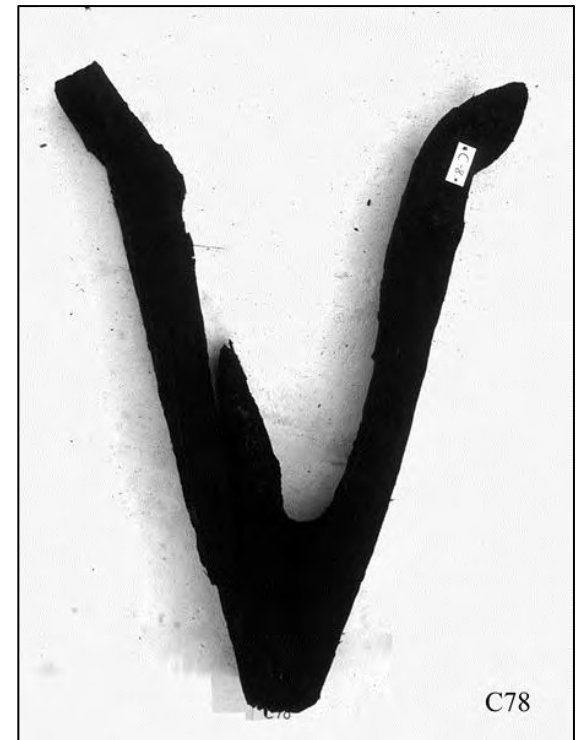
b. Filling timbers;

1. Not numbered;
2. Fastened to the keel with a diagonal spike inserted from the forward of after face;
3. No dovetail scarves;
4. No keel marks;
5. No turn of the bilge marks;
6. At the stern extremity tilted outside with a clear kink;
7. The extreme ones tabbed, sitting on deadwood.

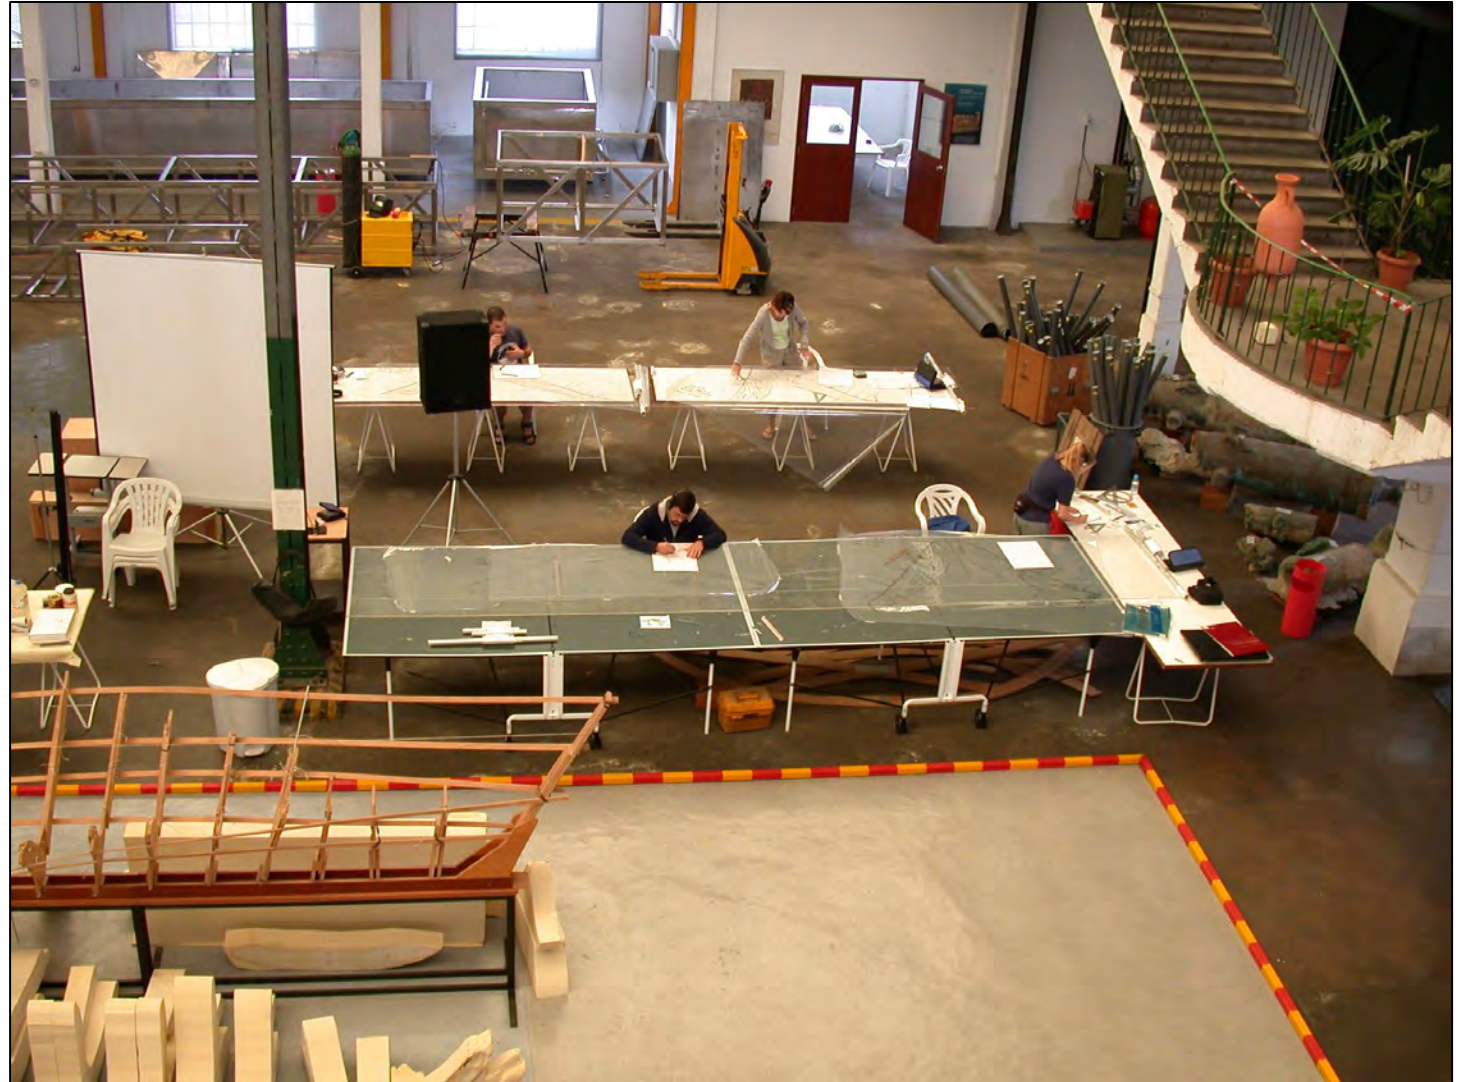
Two Texas A&M University 2001 and 2002 summer schools and record all floor timbers at 1/1 and 1/10 scales.

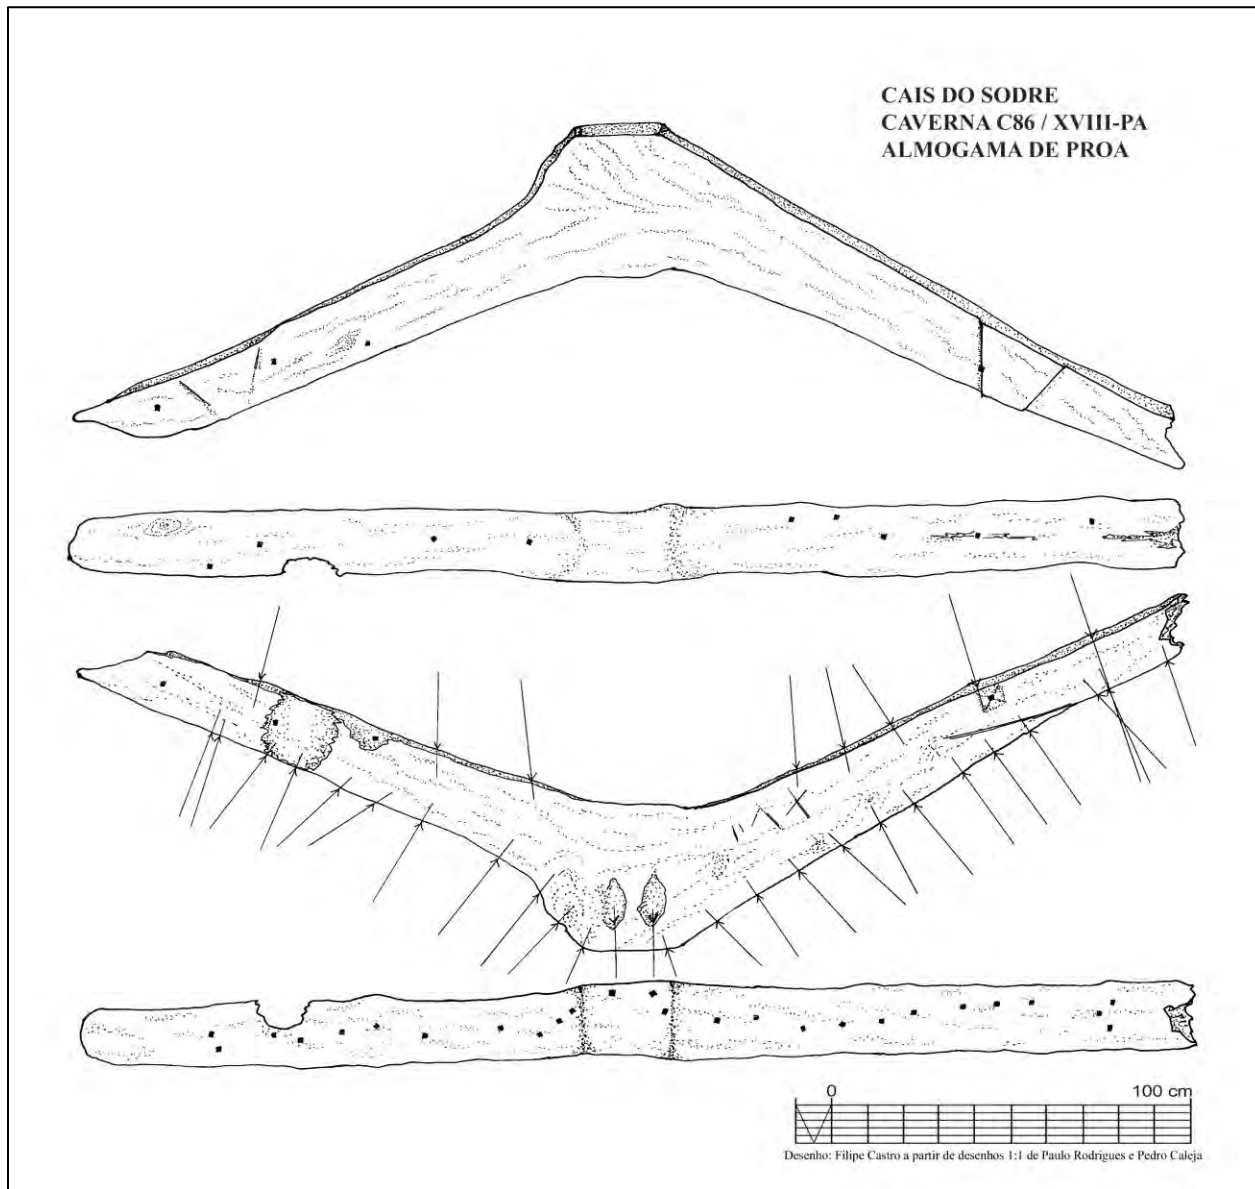
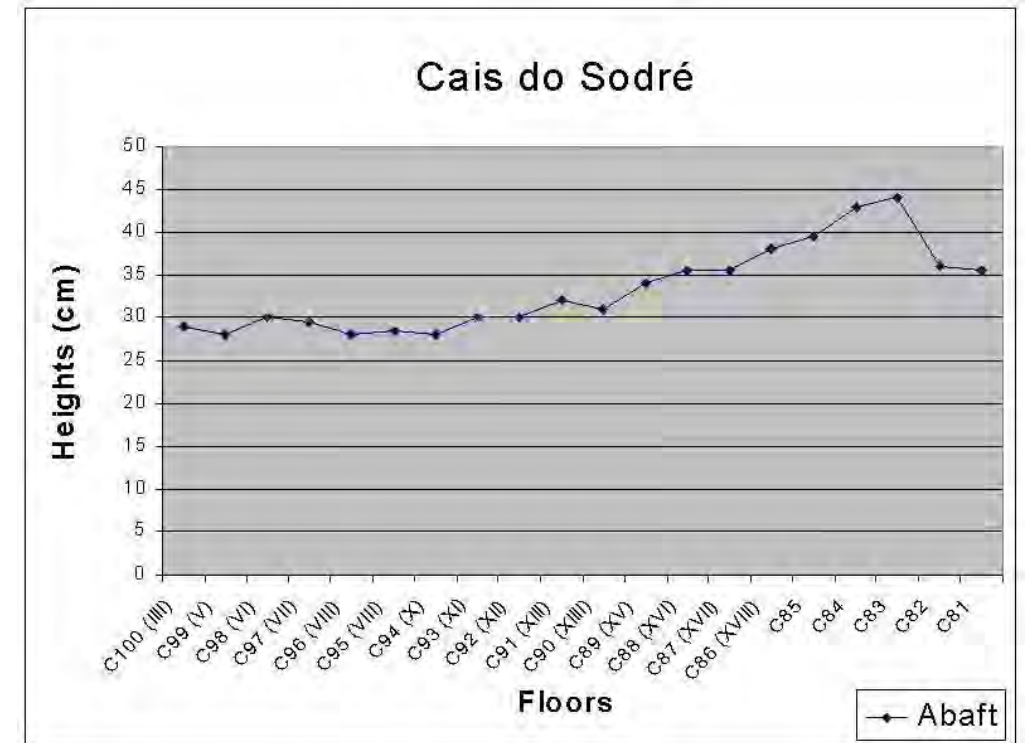
All floor timbers were recorded in 2001/02 and reduced to 1/10 and 1/20 scales, for publication.

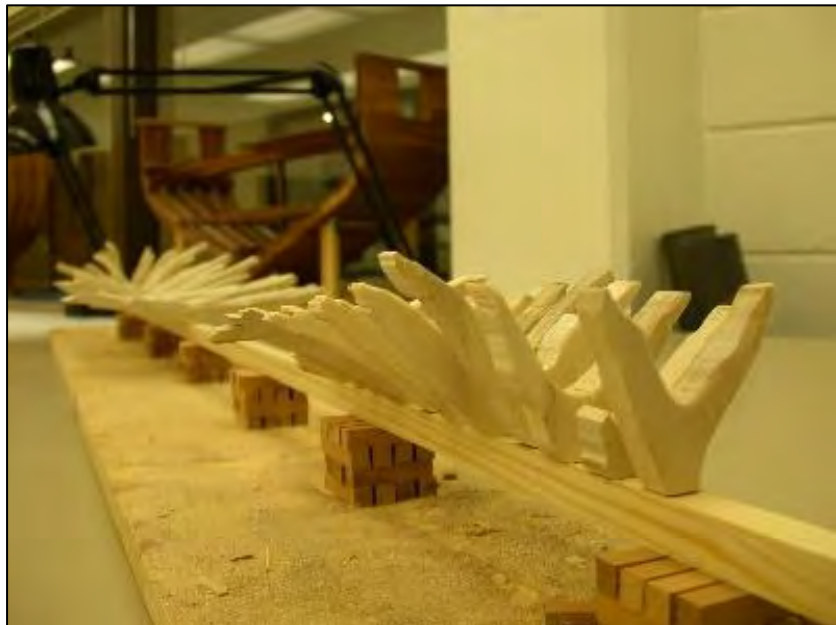
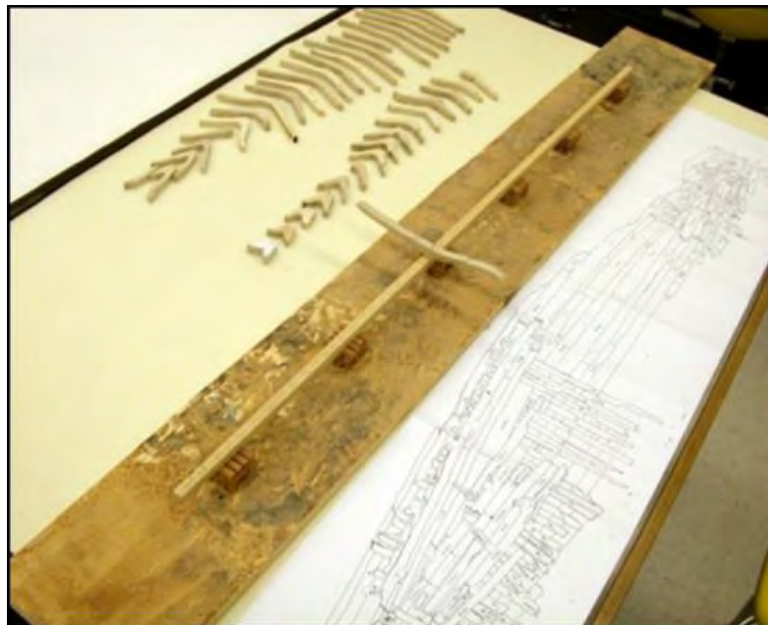
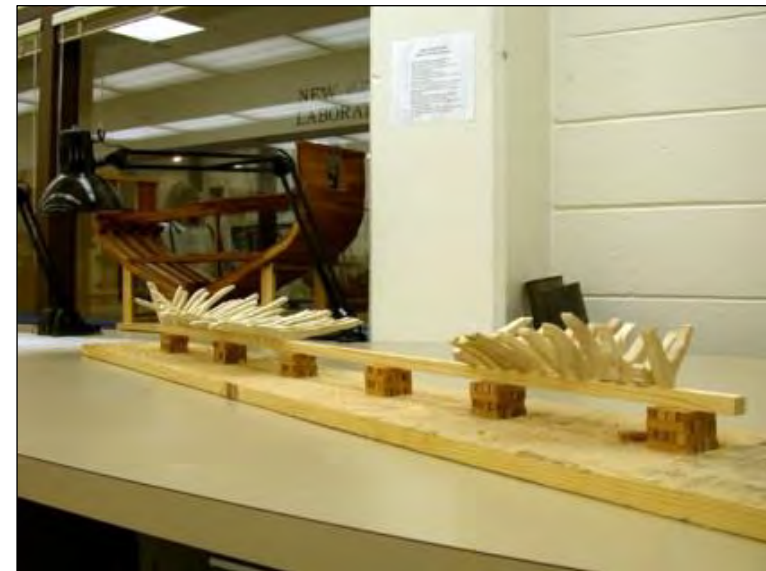
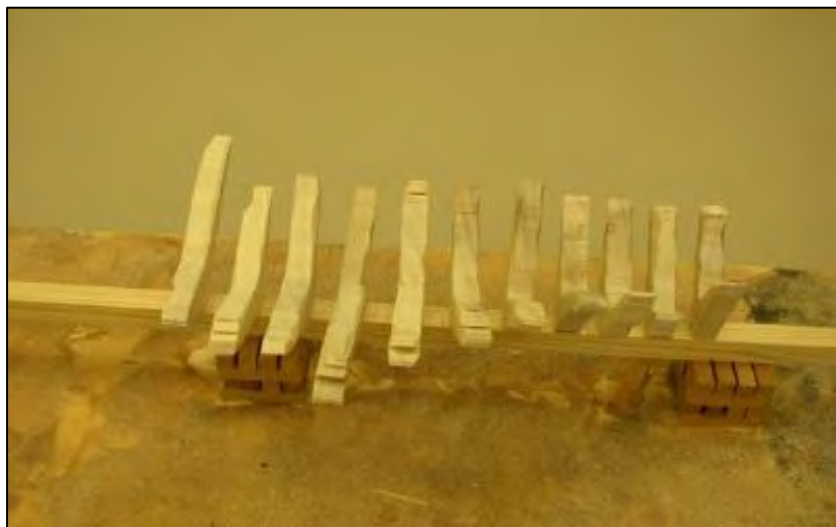
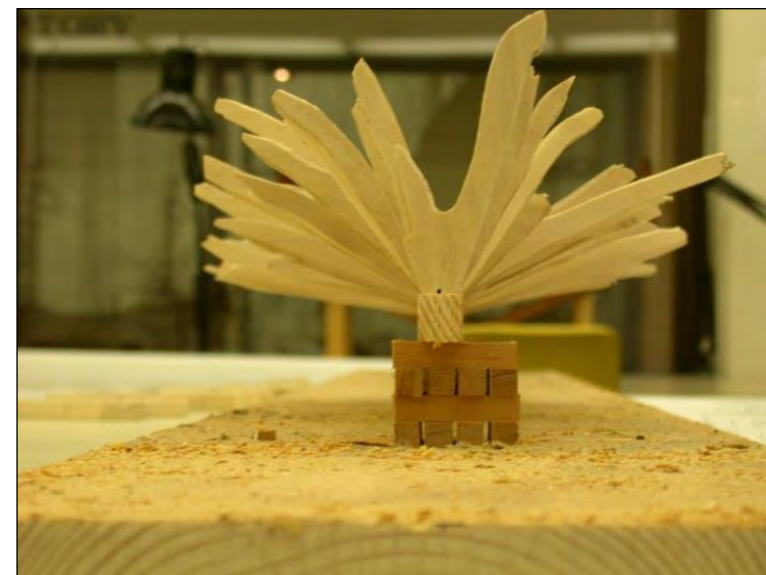
A 1/20 model was developed to assess the warping of the timbers.

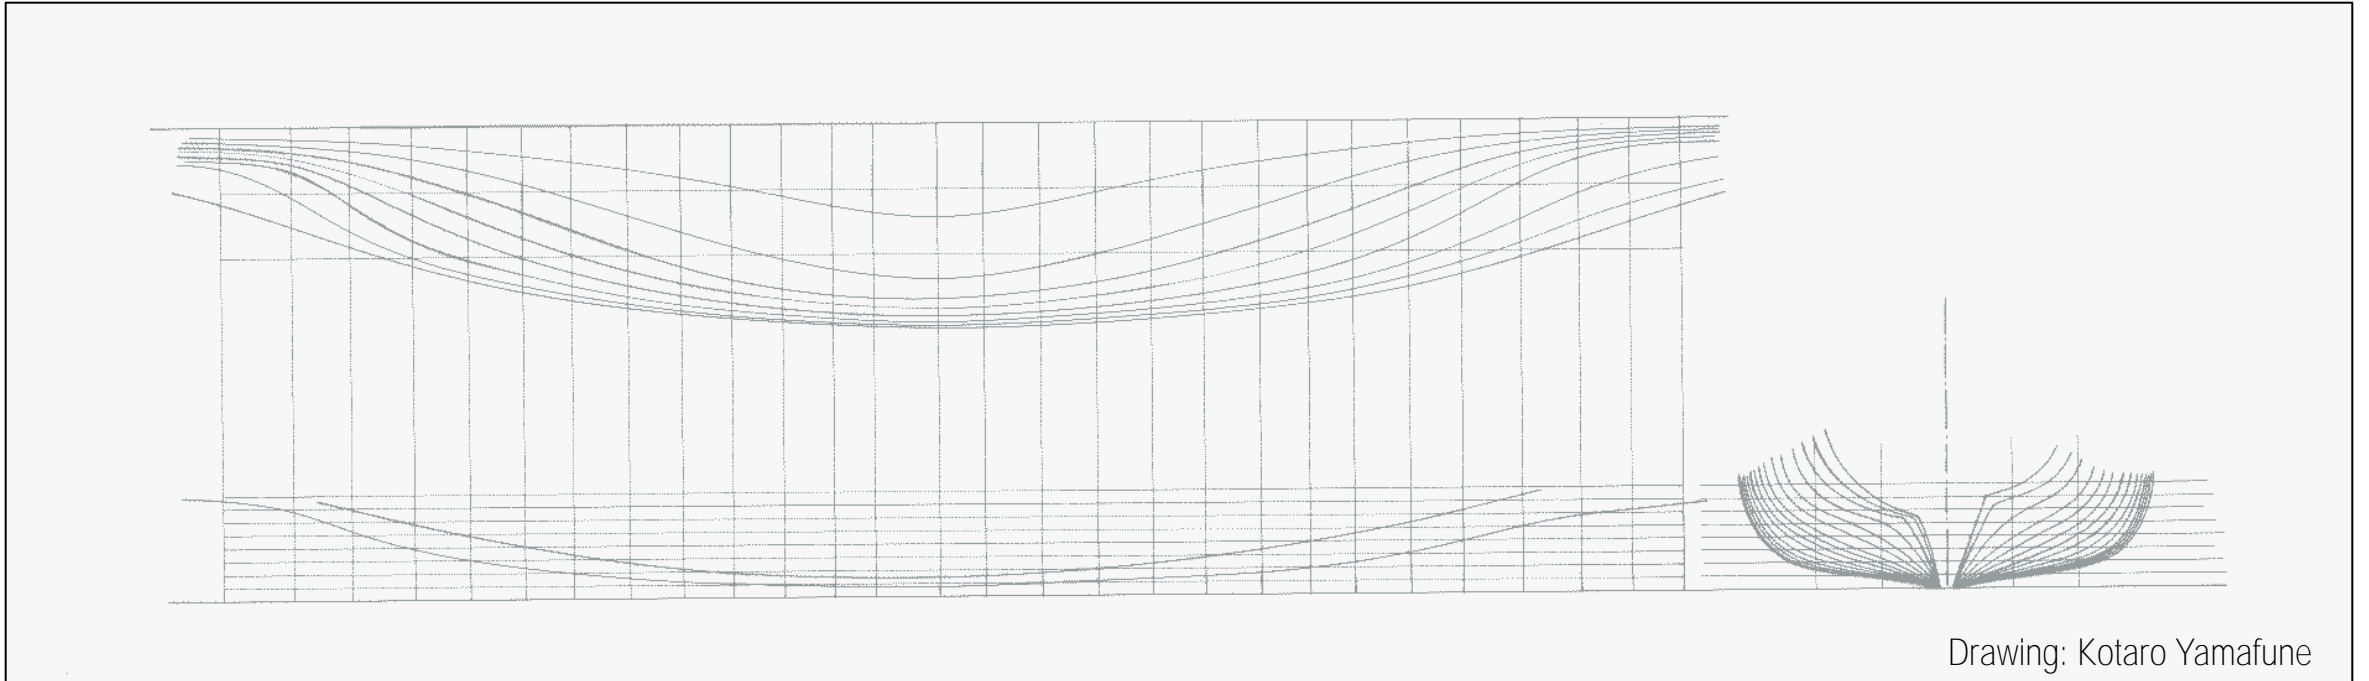
Drawing: Kotaro Yamafune

A first attempt at getting a lines drawing was also produced:

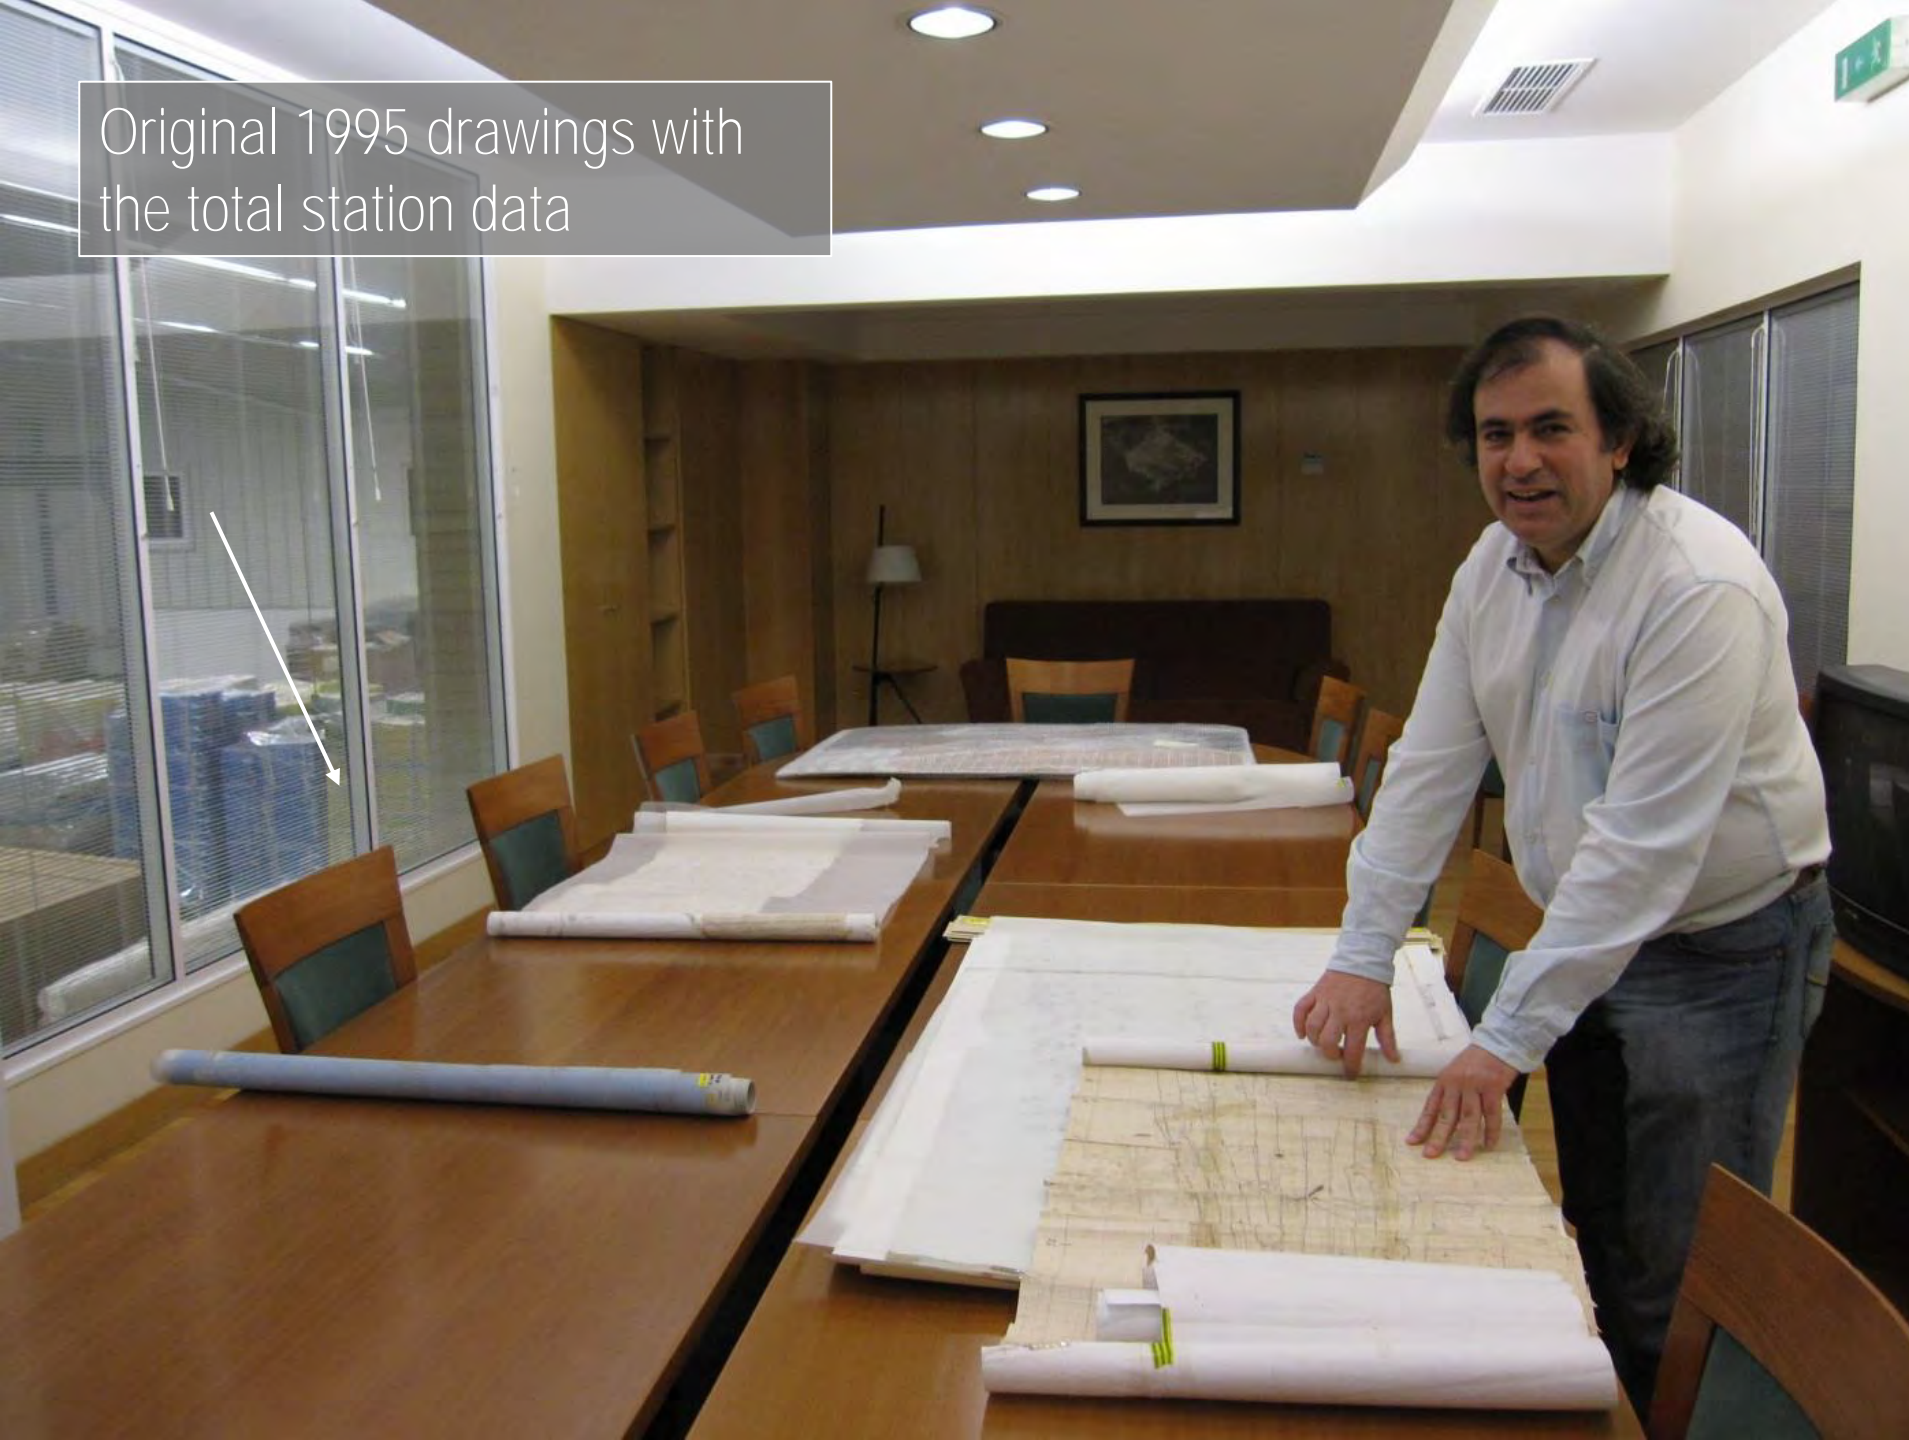
Original 1995 drawings with
the total station data
