Experiencias de intervención e investigación: buenas prácticas, alianzas y amenazas IV

Universidad
Externado
de Colombia

Filipe Castro
Bogotá, April 2021

The Cais do Sodré Shipwreck, Lisbon, Portugal

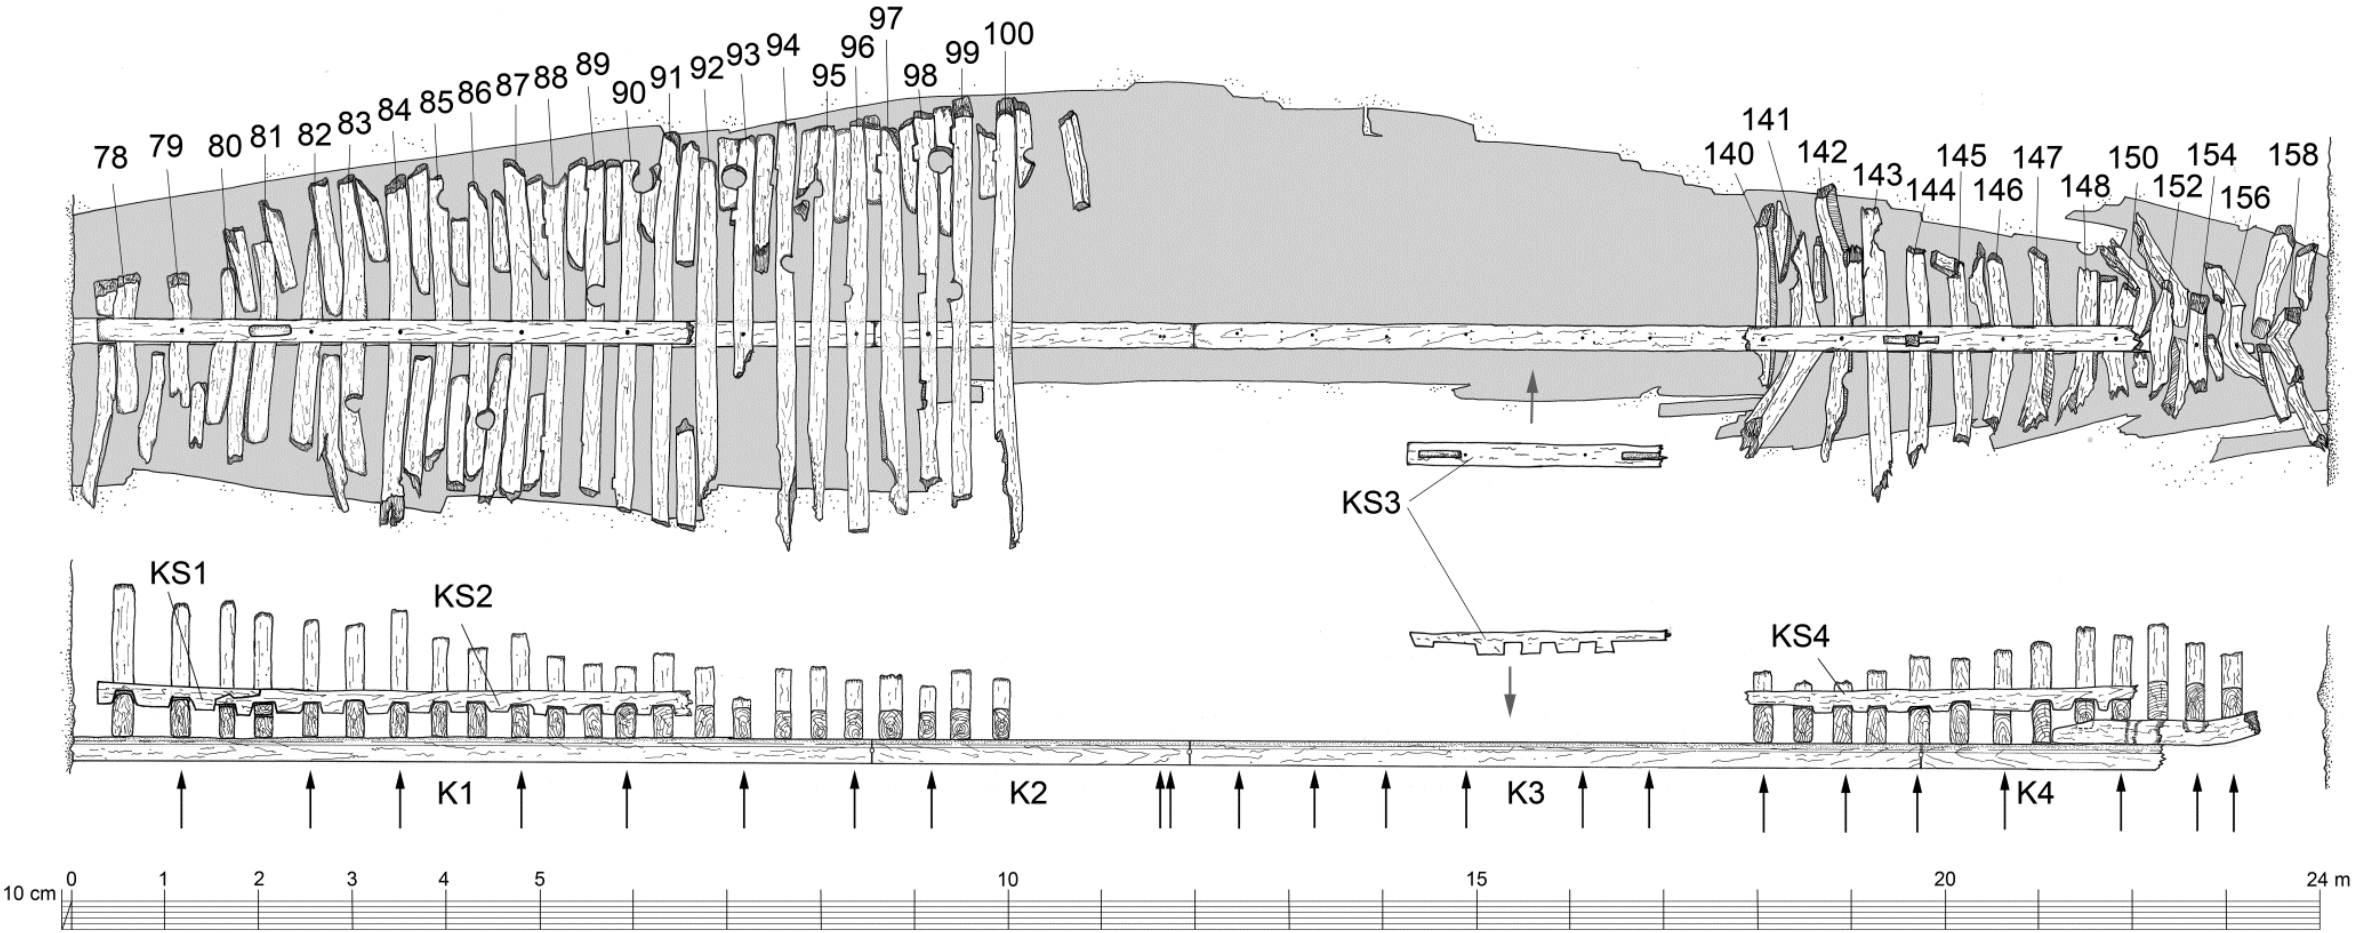
Drawing: Filipe Castro

All timbers were numbered, the spike and bolt wholes referenced, and the position of the keelson reconstructed:

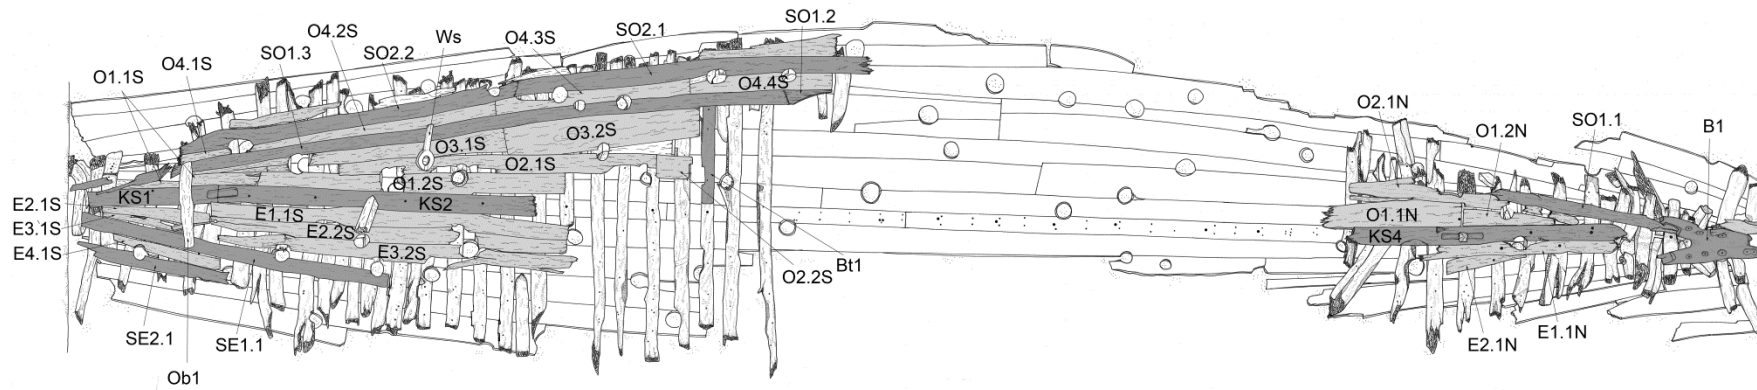
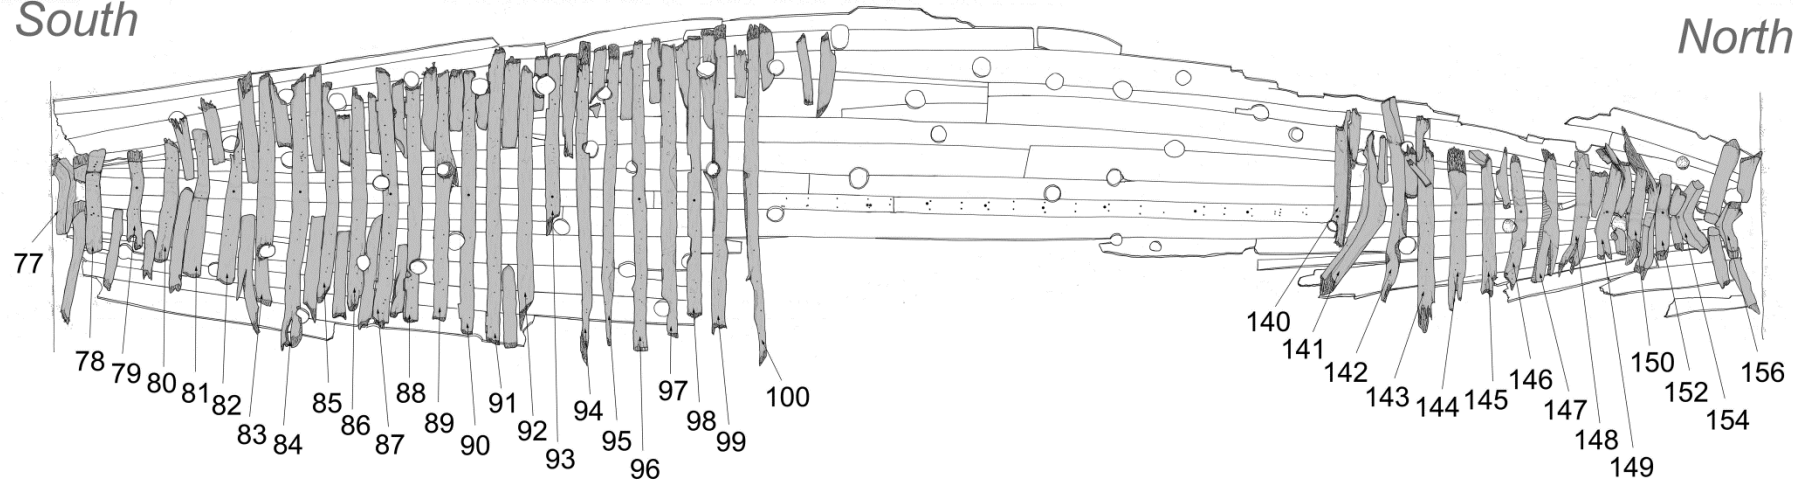
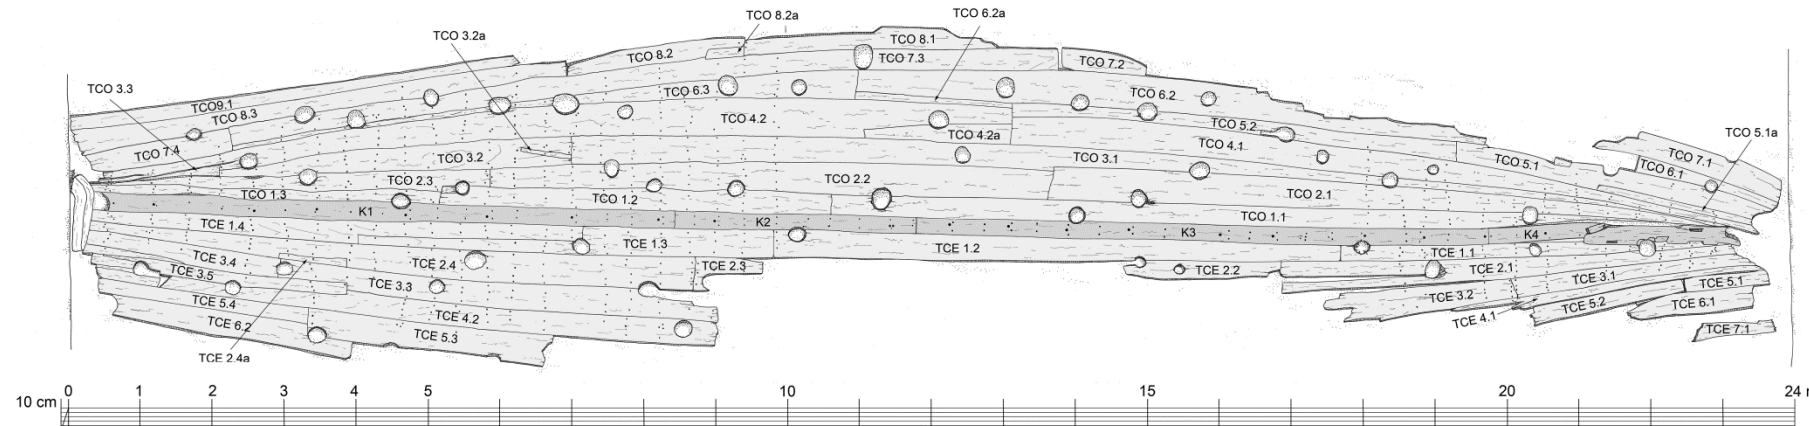
Drawing: Filipe Castro

South

North

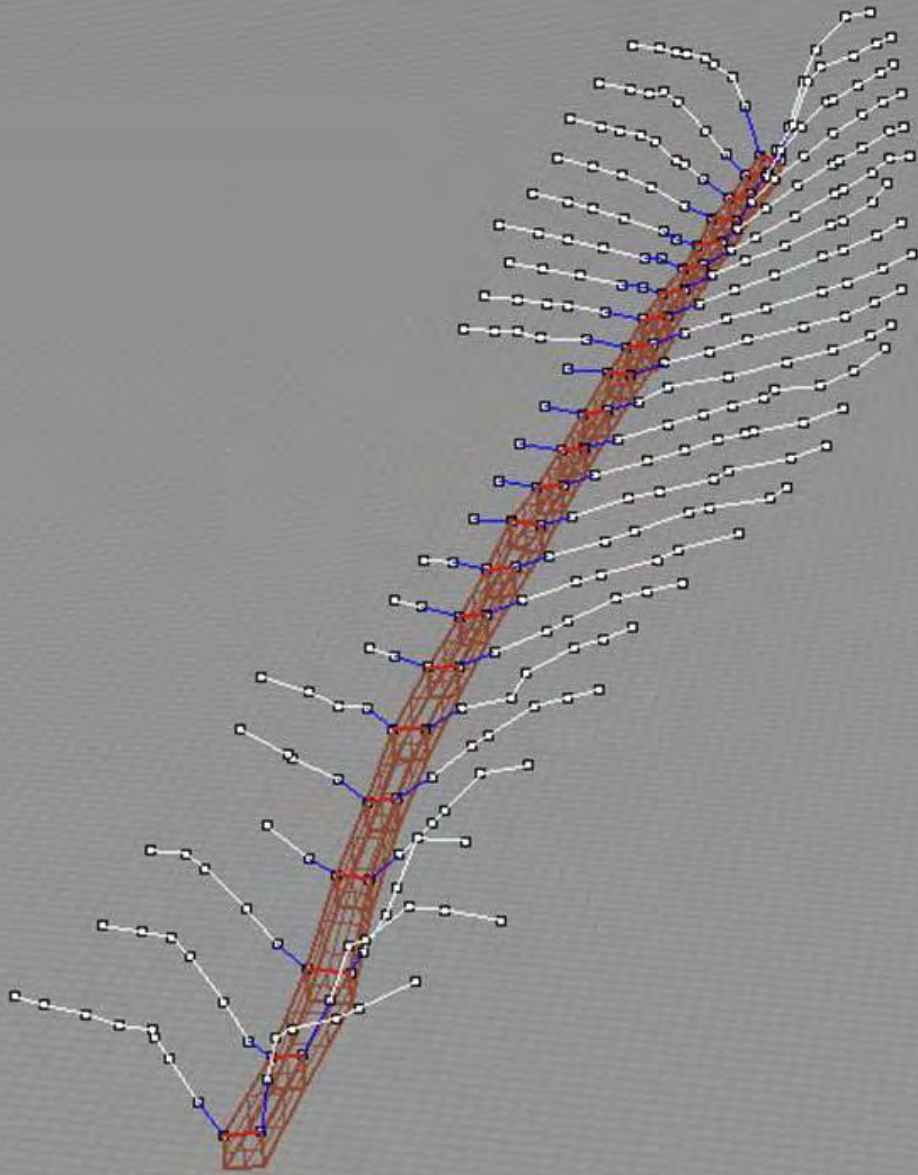
Drawing: Coral Eginton

The total station data were converted into tri-dimensional drawings:

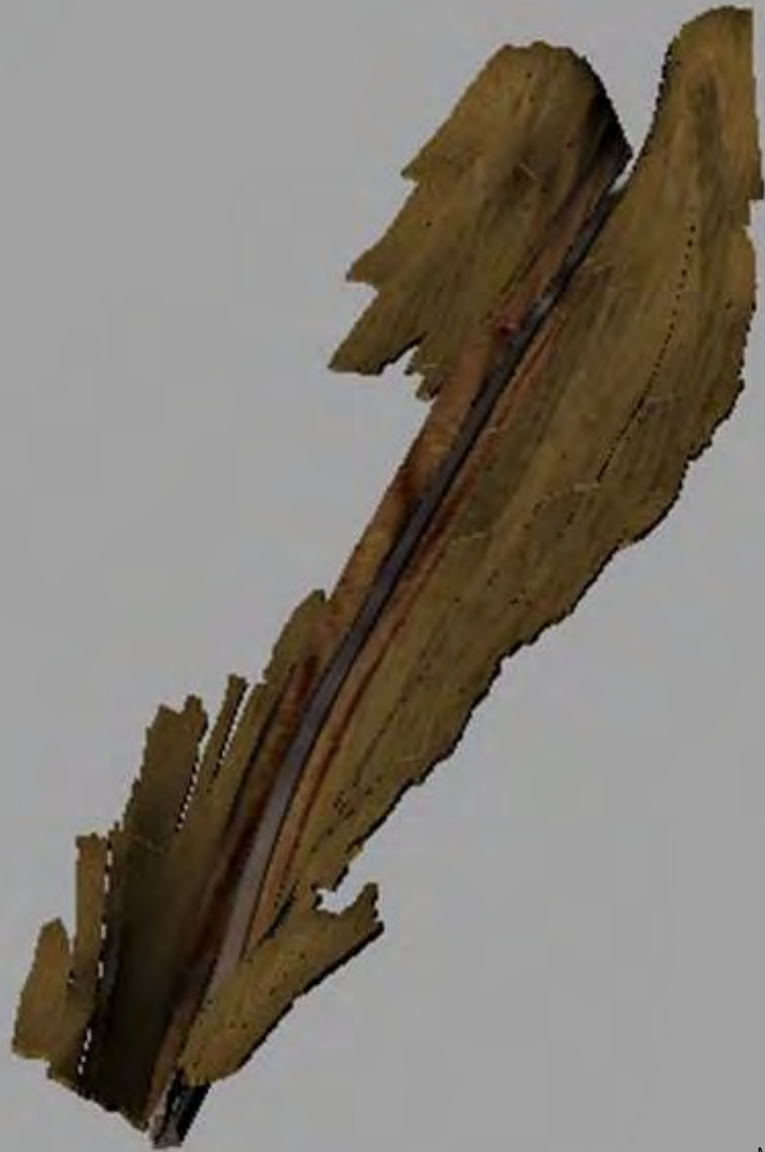
Model: Coral Eginton

A 3D planking plan was produced in *Rhinoceros*[®]:

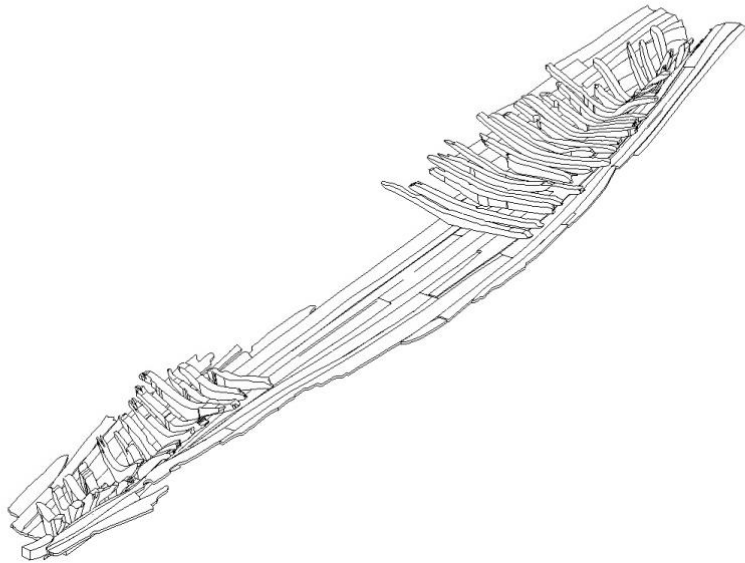
Drawing: Thomas Derryberry

A new hull plan was produced with *Rhinoceros*[®] software:

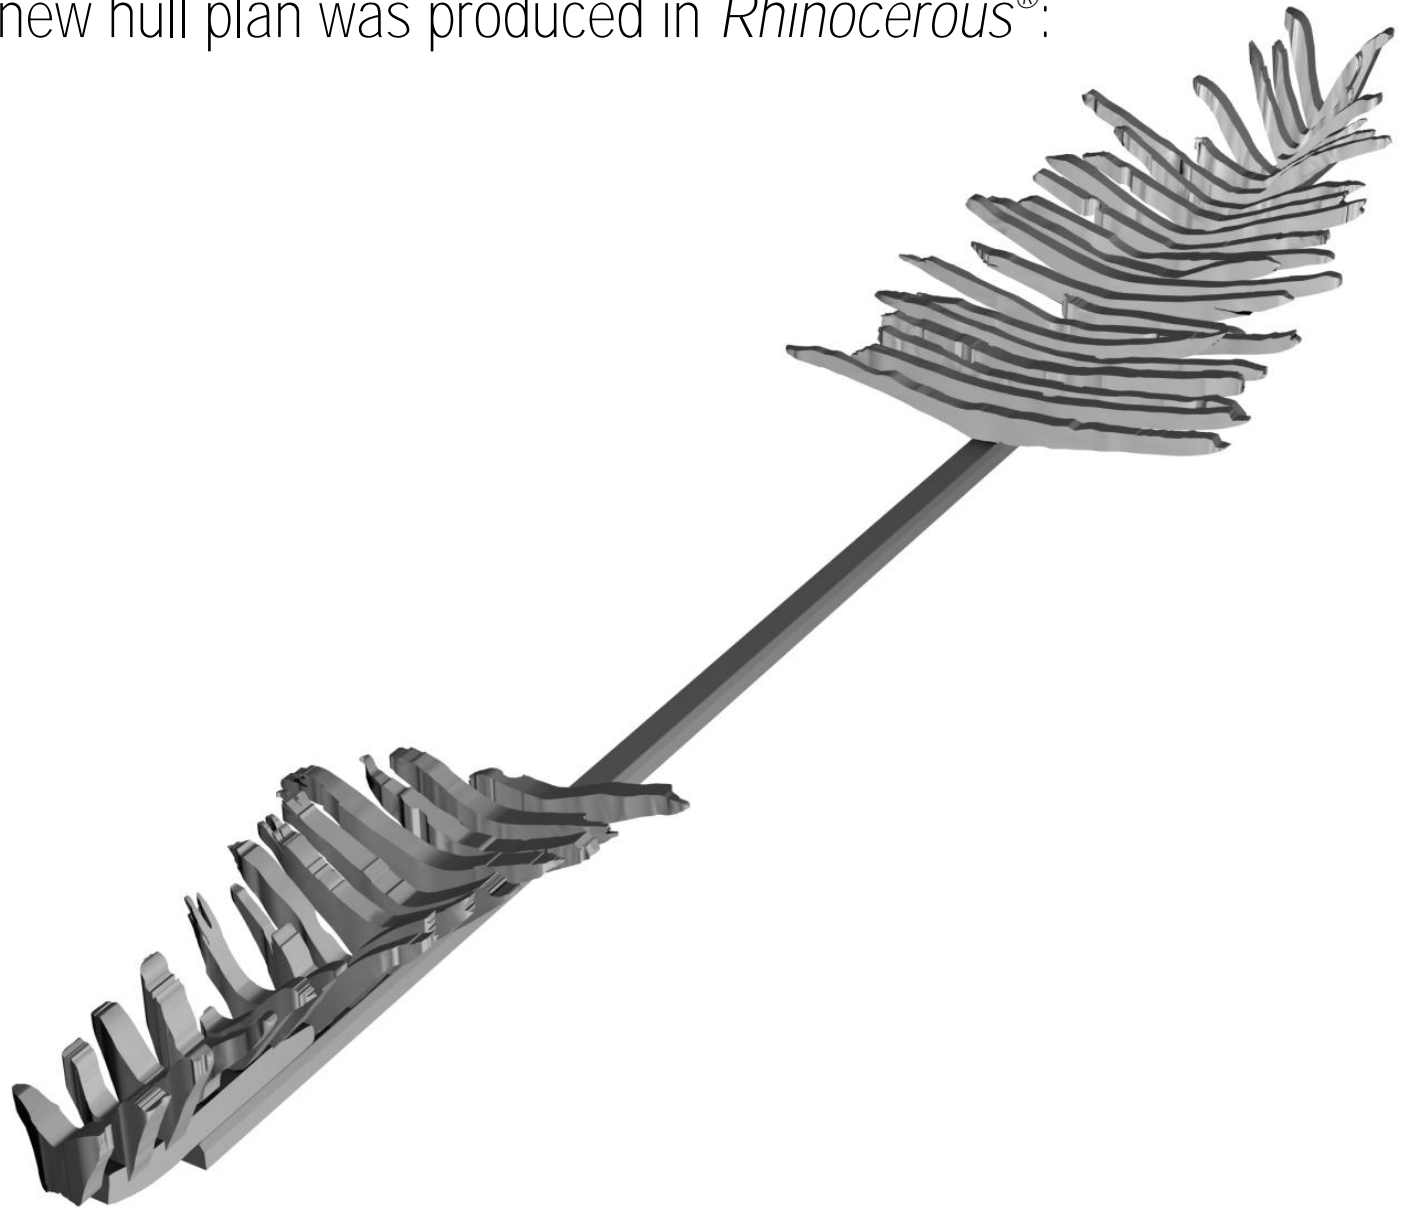
The keel was then straightened, and new hull plan was produced in *Rhinoceros*[®]:

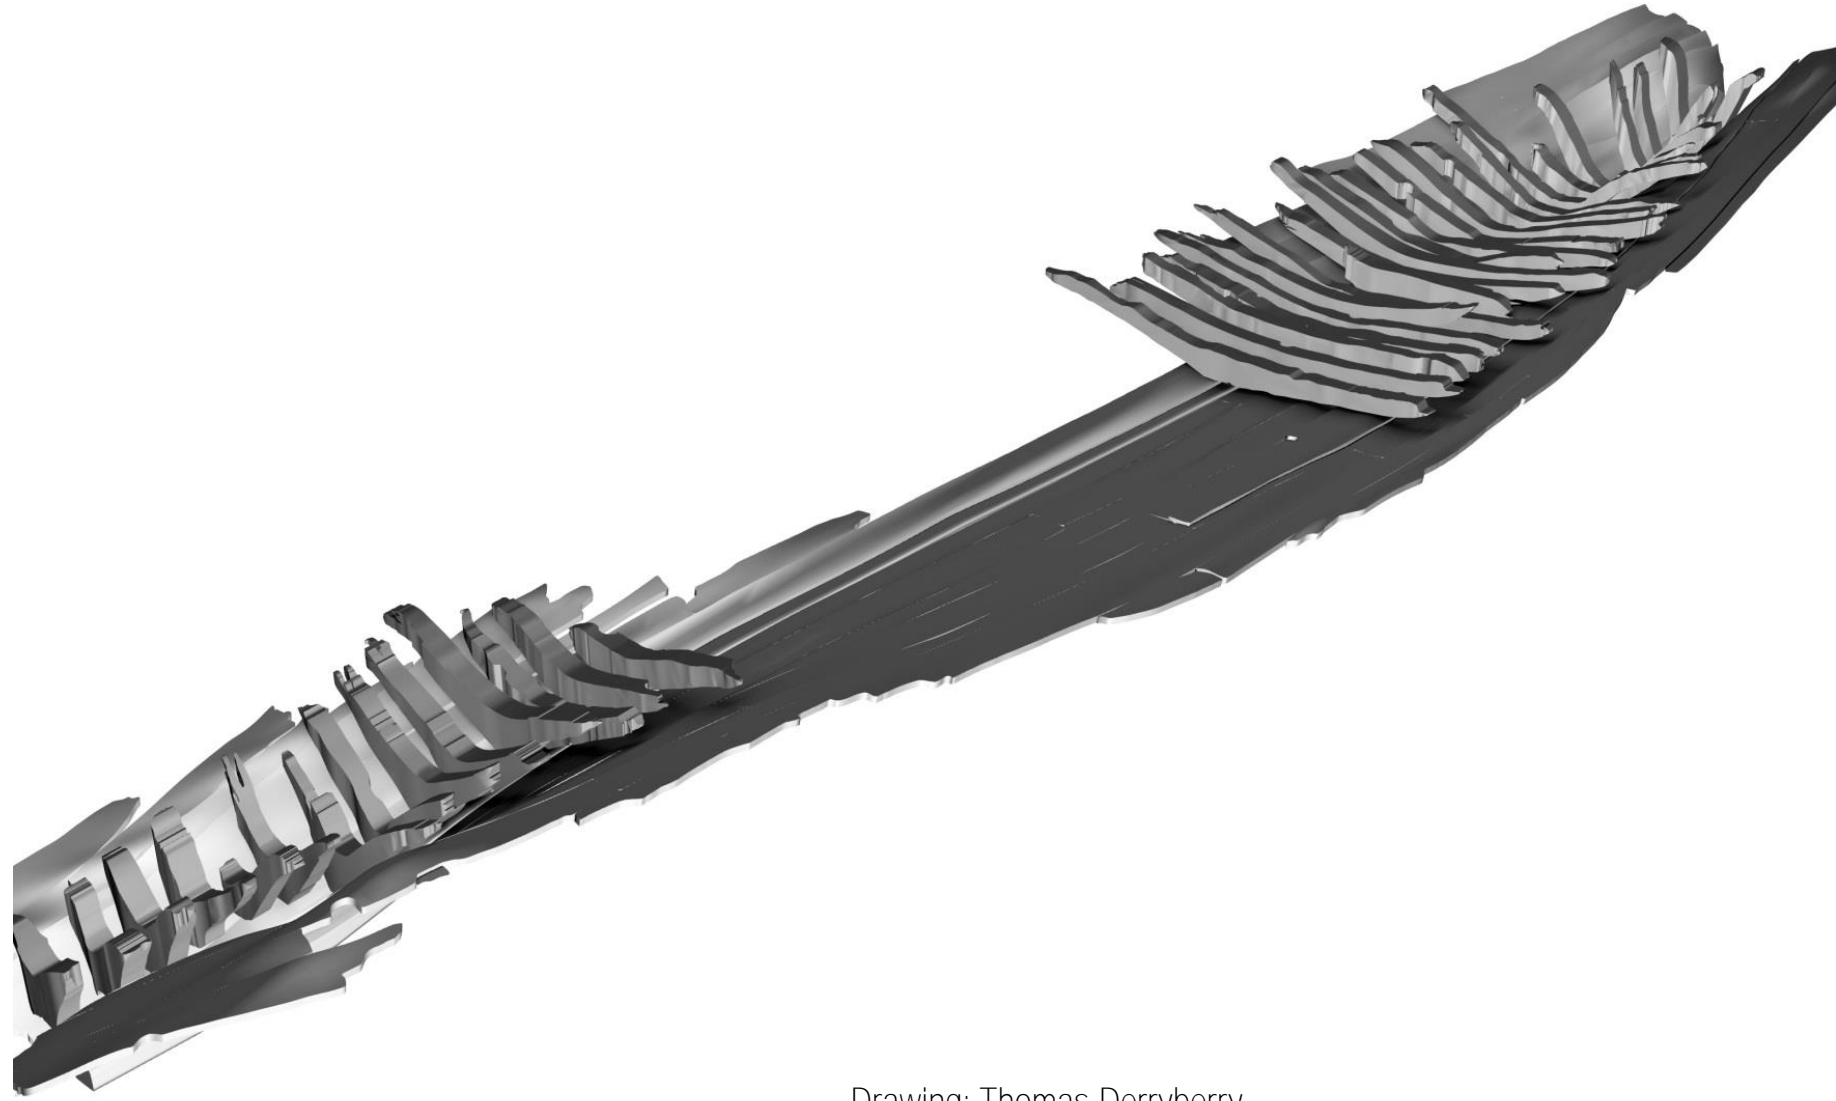
Drawing: Thomas Derryberry

A new hull plan was produced in *Rhinoceros*[®]:

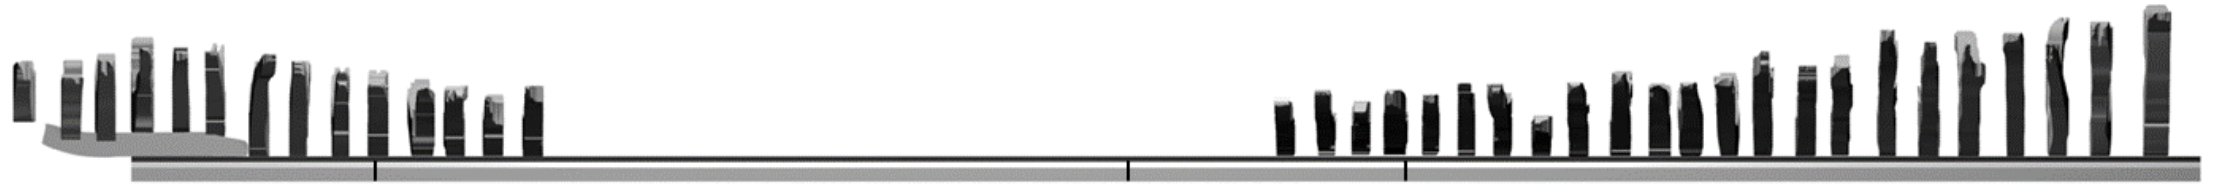
Drawing: Thomas Derryberry

A new model of the shipwreck was developed and used to analyze its structure.

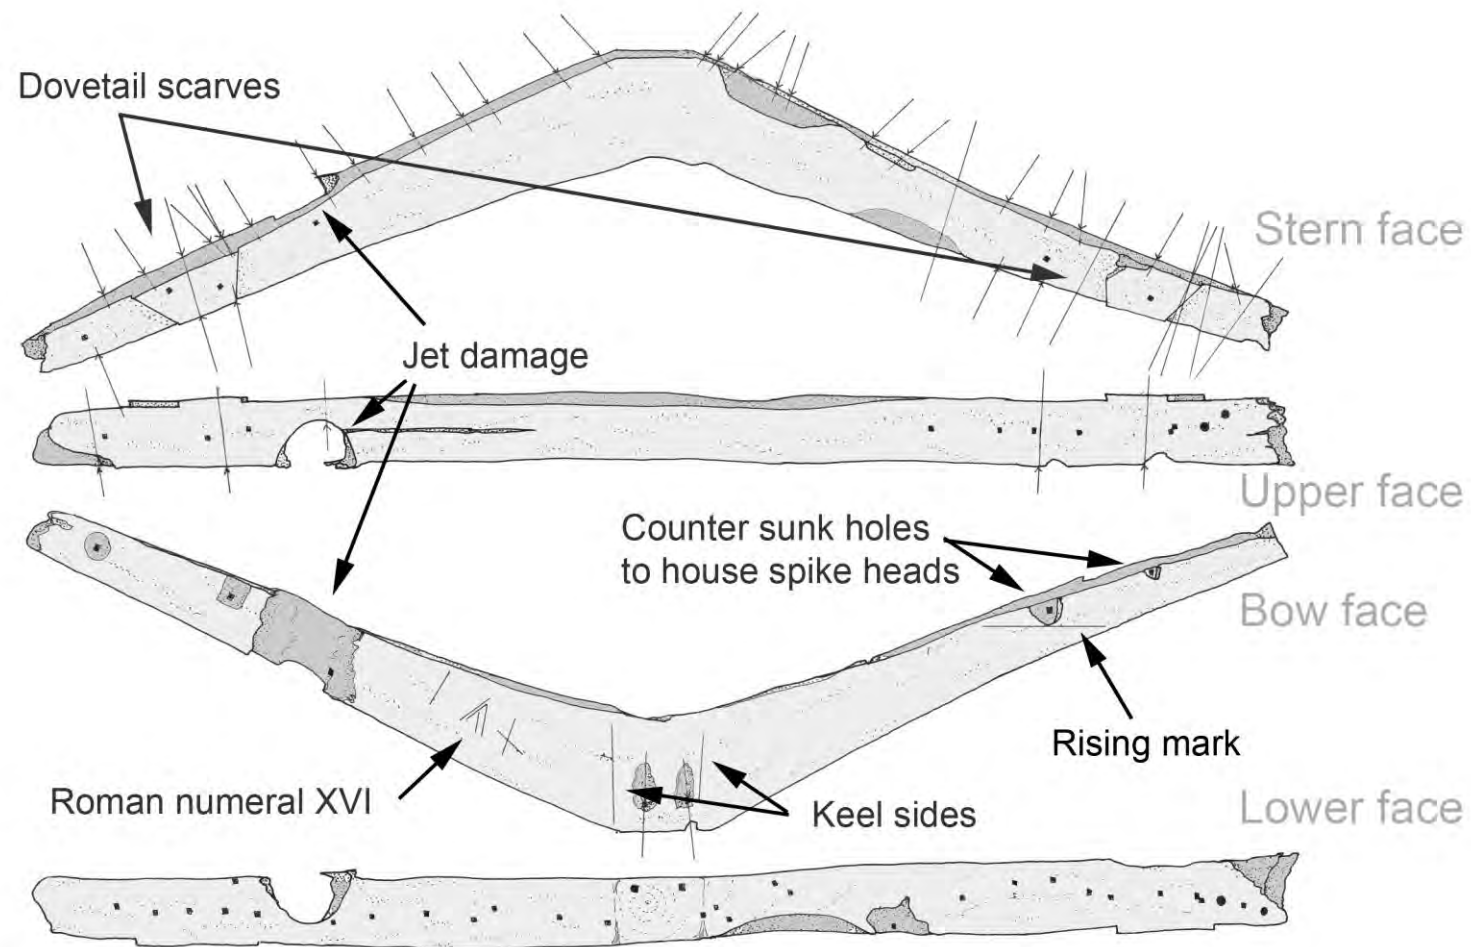
Drawing: Filipe Castro

The most important characteristic of this shipwreck were the construction marks inscribed on the floor timbers:

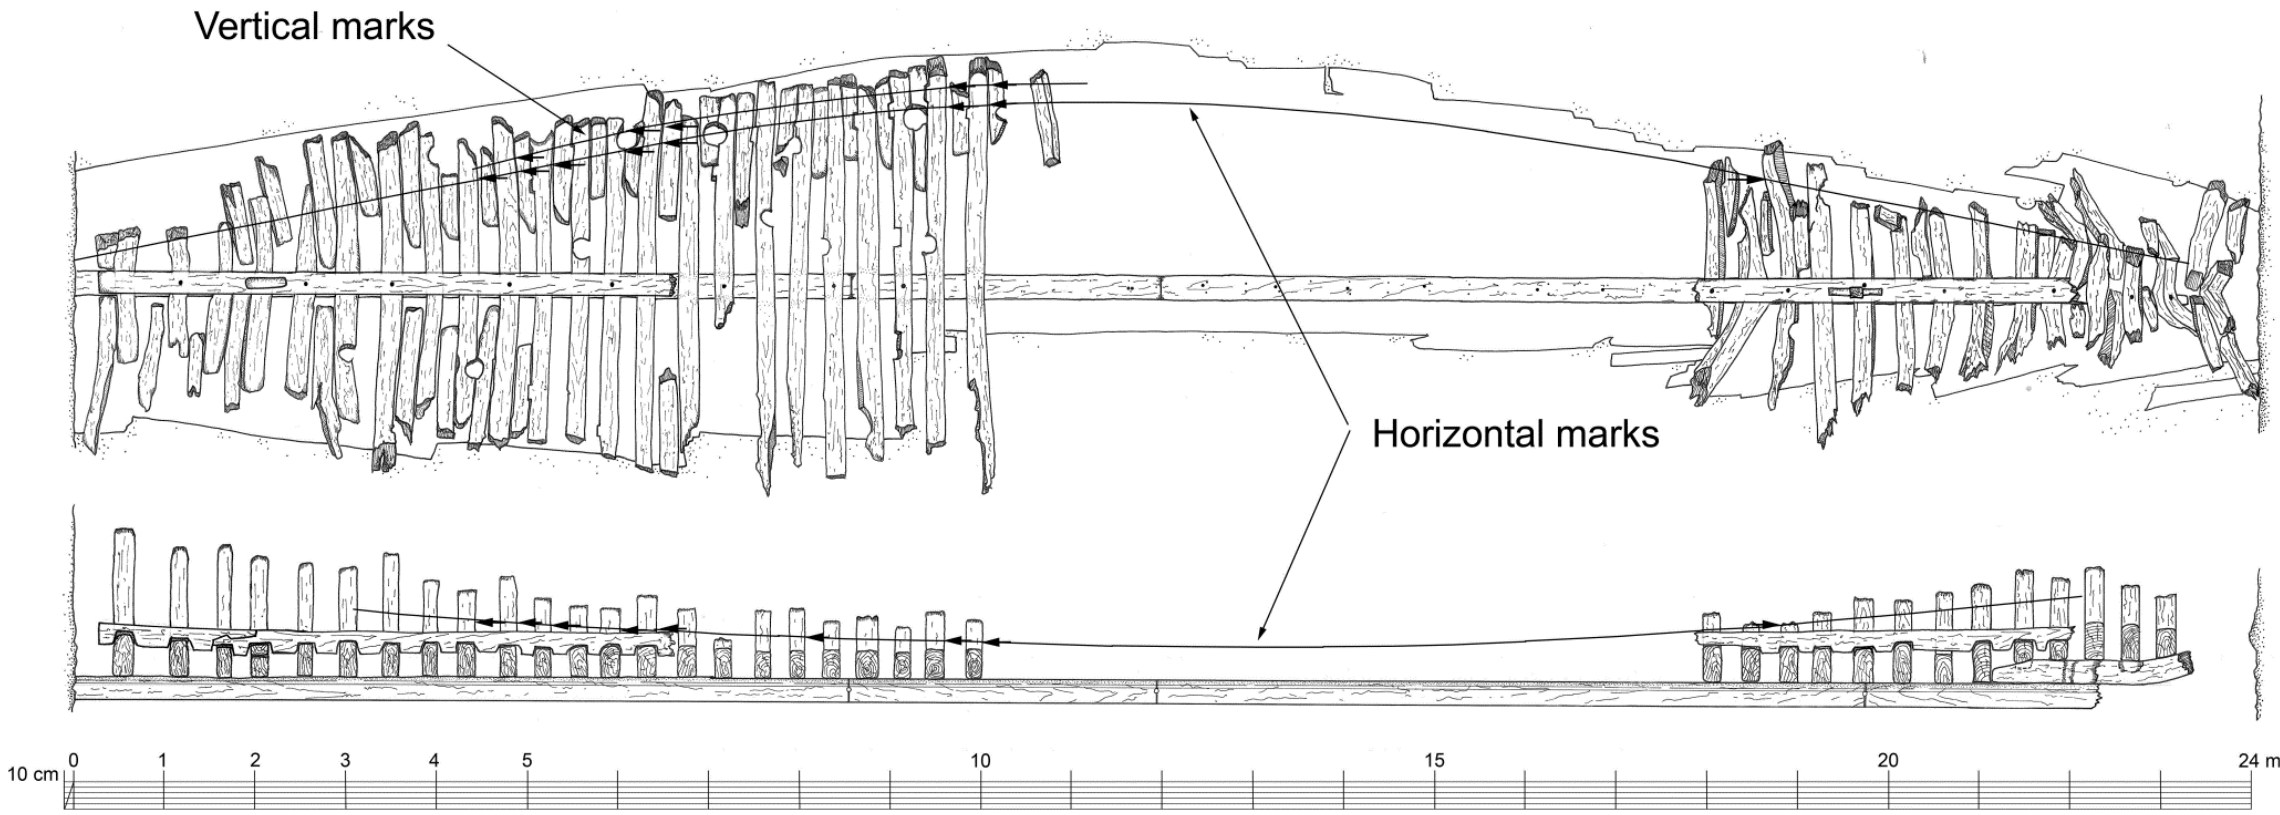
Drawing: Filipe Castro

A first attempt to understand the rising and narrowing patterns failed to yield a clear method:

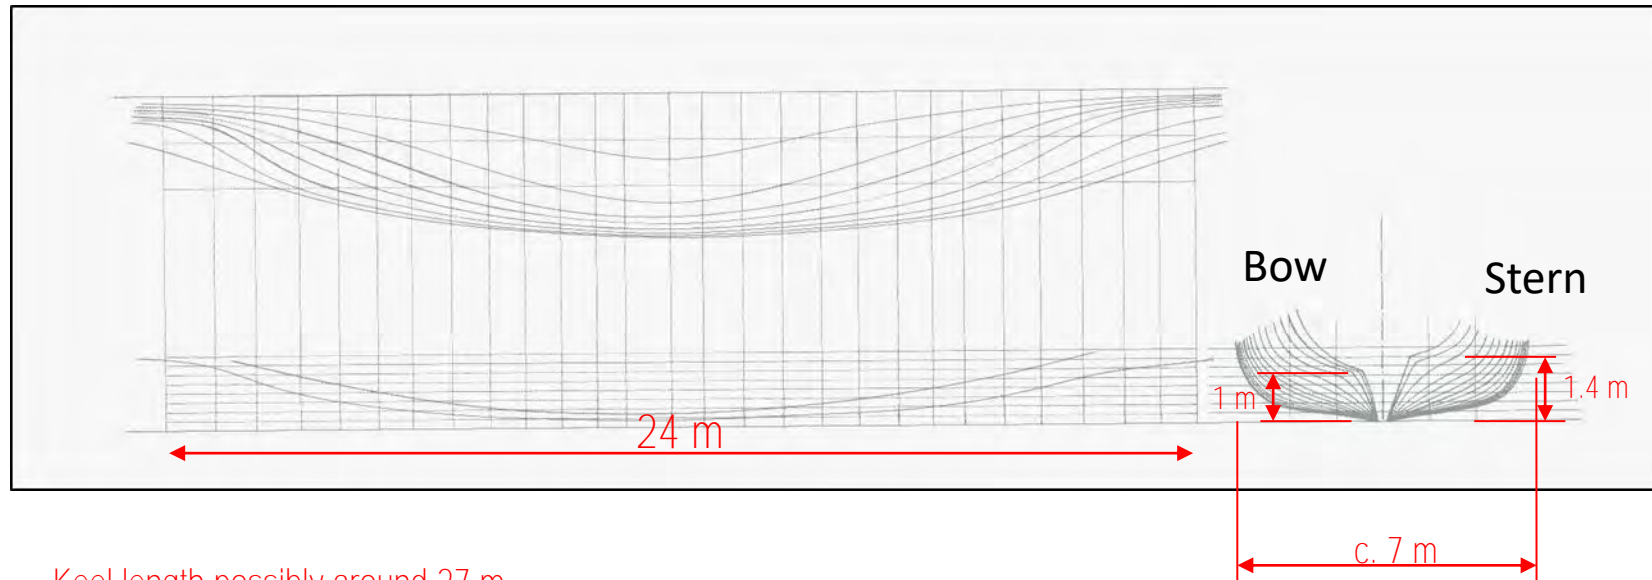
Given the shapes of the entries and runs and taking into account the relatively light scantlings for the size of this ship, we believe that this may be a type of river craft.

Keel length possibly around 27 m
Max. beam possibly around 8-10 m
Height of the runs possibly not more than 3 m
Height of the entries possibly around 2 m

The presence of a fragment of a whipstaff in the ship bilge – assuming that it belonged to this vessel – argues otherwise. Only further research may shed some light on this study, which is just starting.

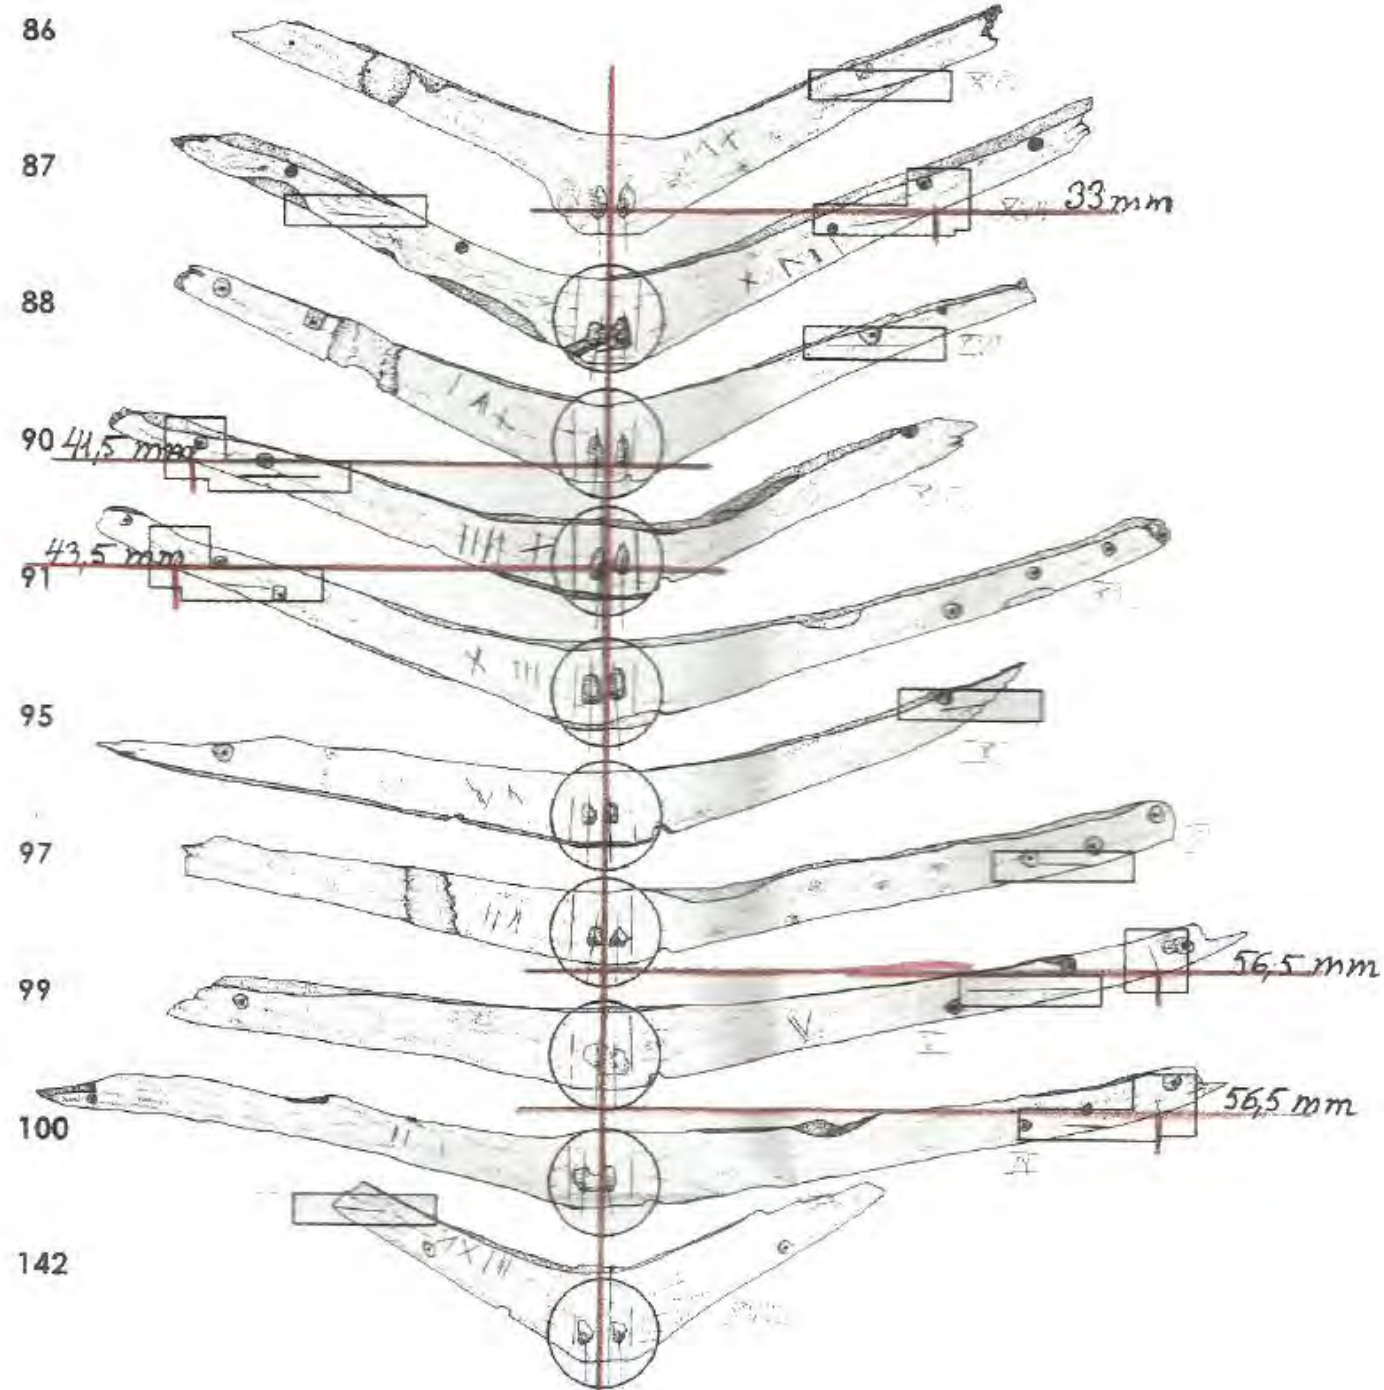
Paul Bloesh calculated the narrowing of the floor timbers abaft from 5 known values and obtained a fair and plausible curve.

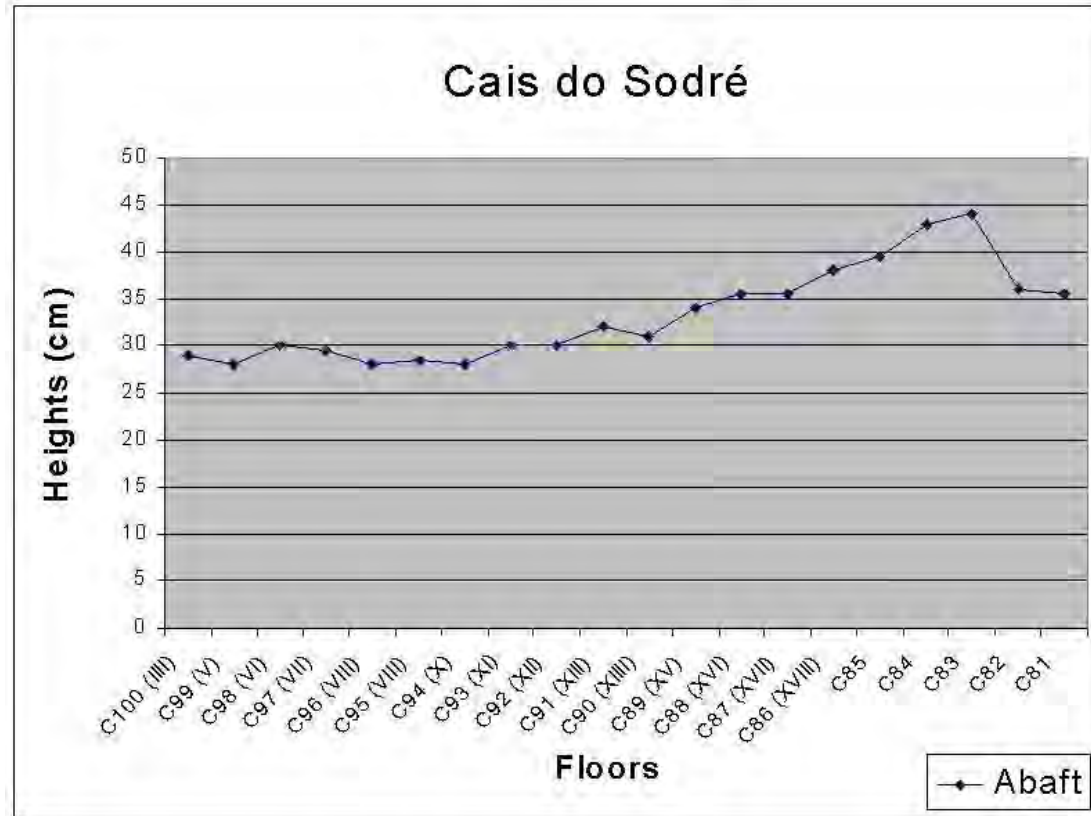
Cais do Sodré, reconstitution des diminutions arrière (méthode du triangle)
